## LOCATION OF ILS SCATTERERS

### Touko Hahkio

### ABSTRACT

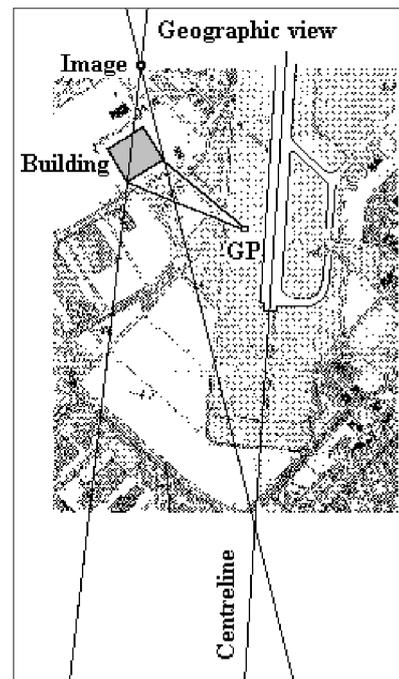
Figure 1. Geographic view

Several questions remained still open. Why should the localiser width be halved? Why was the wall aligned as it was? Why an up-to-date geographic map (Figure 1) was not immediately available?

Missing up-to-date maps misled the analysis at the outset. The engineer responsible of radio navigation aids simply received them from the construction sector with some delay.

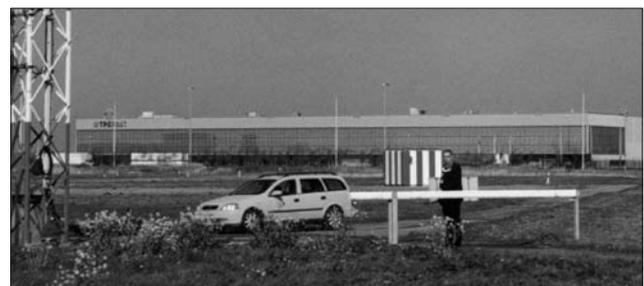
Figure 2. View towards the reflecting wall

Soon thereafter I received an up-to-date map of the area. There was a big building behind the GP antenna. Its metal and glass wall, some 170m long and about 14m high, reflected the back radiation from the GP antenna exactly in the direction of arriving aeroplanes. It created a point-like mirror image of the antenna.

The reflecting wall (Figure 2) of the building had been erected with nice architecture in mind. It was aligned with the centreline of a crossing runway. Had it been aligned otherwise the back radiation of the antenna would have pointed to a harmless sector.

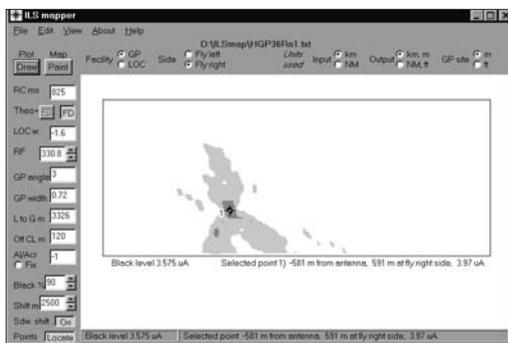
Figure 3. ILSmapper view: co-ordinates of the image of GP antenna

Three months later further flight data arrived. The map converged to a point some 600m from the centreline and about 600m behind the antenna, if the localiser width was halved. Geographic maps available indicated nothing there.
