Elimination of ILS Navigational HMI in the Operational Environment

Mickey V. Lindecker Jr.
ILS Field Support Engineer
FAA AJW-143
Oklahoma City, Oklahoma
Fax: 405/954-8378
Phone: 405/954-5197
E-mail: mickey.lindecker@faa.gov

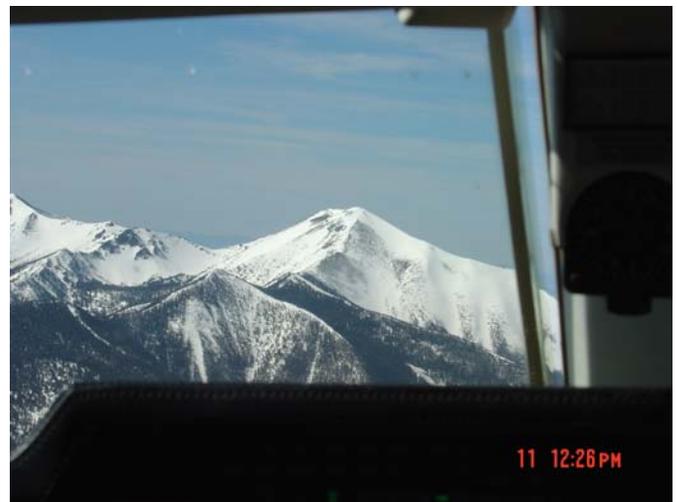
Figure 1. PRC Localizer Course Over Mount Humphreys

- Run #7: The purpose of this run is to intercept PRC LOC course at approximately 65 NM (120 km) and 13,500 ft (4,115 m). If found, fly it to over Mount Humphreys to Prescott and record RF signal strength. PRC course was present and flyable (Ref. Figure 1).

- At 13,500 ft (4,115 m) and 65 NM out, again behind Mount Humphreys, the PRC LOC centerline was present and flyable (20 & 26 μ V two receivers). This indicates that the PRC centerline signal is of sufficient strength to fly, behind the mountain, somewhere between 10,000 ft (3048 m) and 13,500 ft (4,115 m).

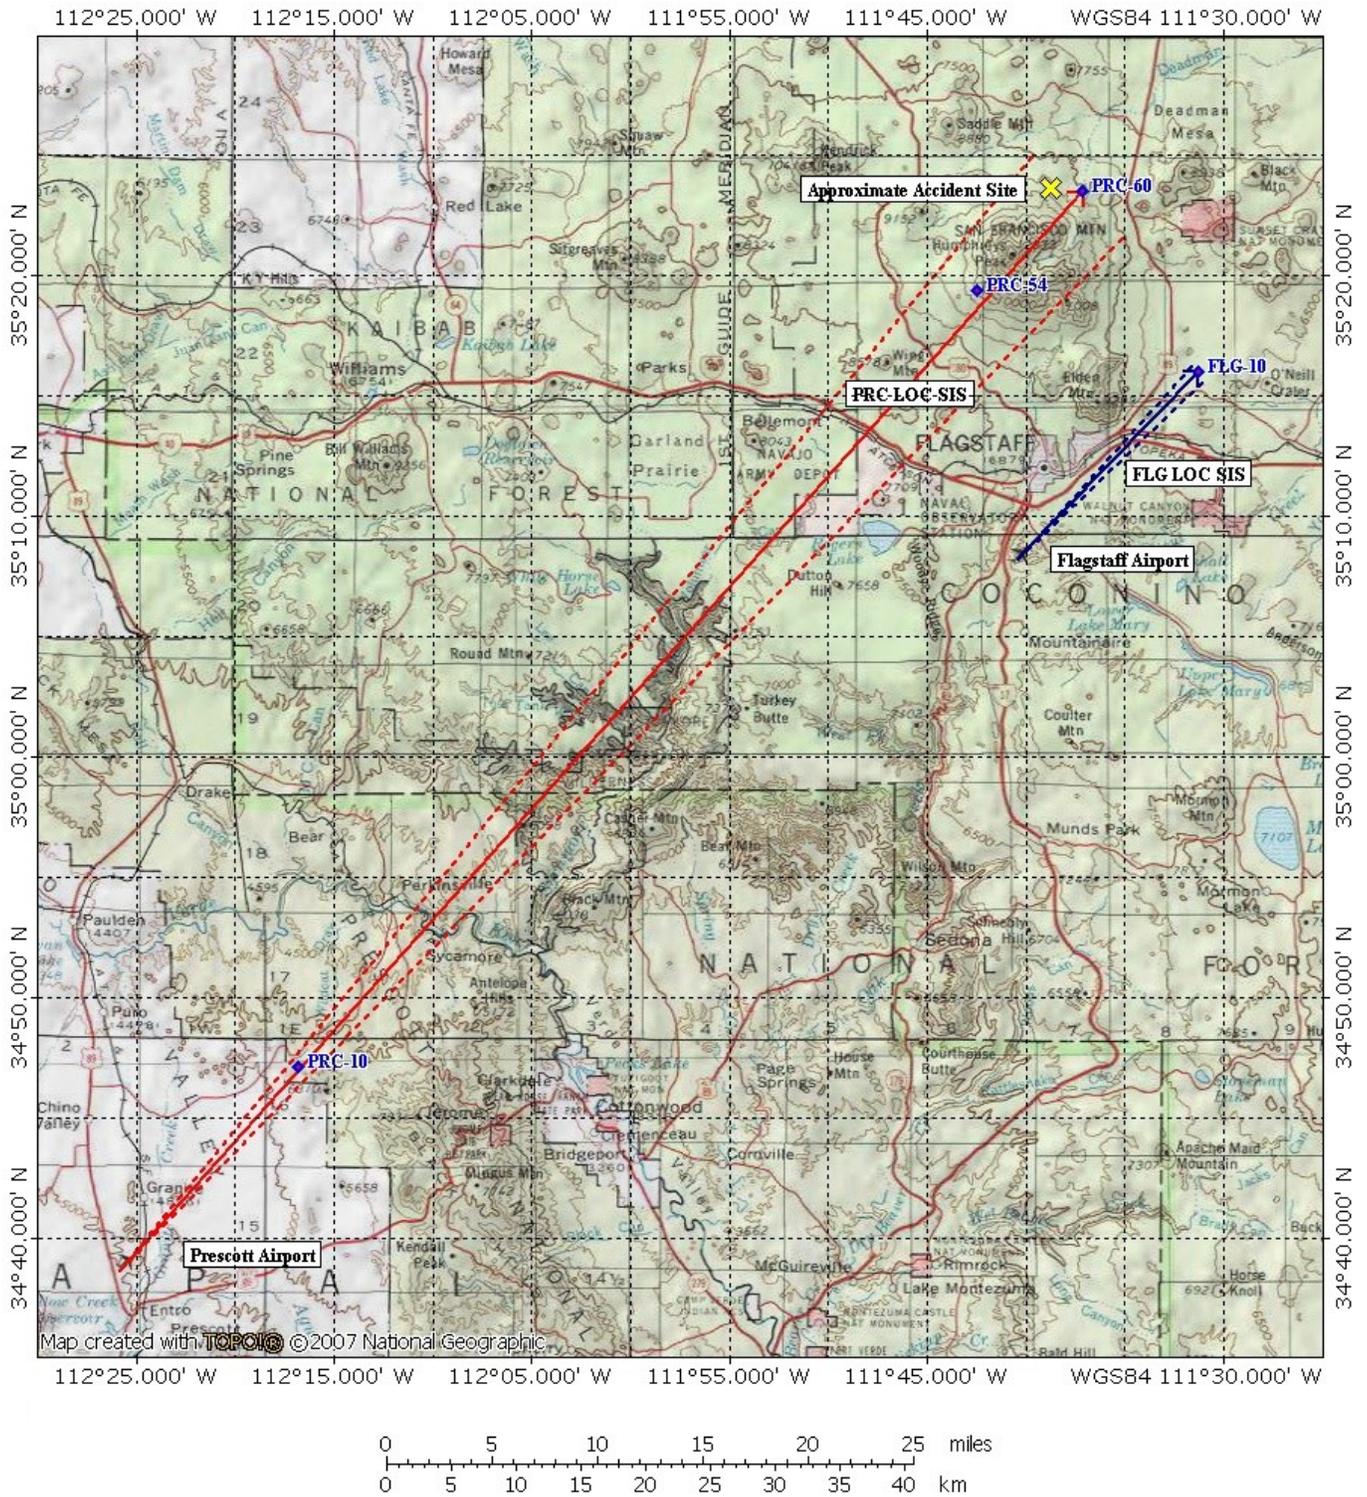
Figure 2. PRC and FLG Localizer Signals and Approximate Accident Location

There seems to be some discrepancy in the various reports; perhaps due to the dates they were prepared. A brief of the accident says that the crashed occurred on the southeast side of Humphreys Peak. The more detailed Factual Report puts the location of the wreckage on the northeast side; at the 10,500 ft (3,200 m) level along the 354° radial, about 15 DME from the Flagstaff VOR and 10 miles (16 km) west of the final approach course (Ref. Figure 2).

Some of the flight inspection results are noted in Table 1: Flight Inspection Run Sheet (March 11, 2008), in blue italic font. Also, a map of the area is shown in Figure 2: PRC and FLG Localizer Signals, with some of the as-found Lat/Long coordinates plotted. Course widths of the Localizers are shown drawn in (i.e. dashed lines); Red lines indicate the PRC LOC, with blue the FLG LOC. PRC 10, 54, 60 points represent the PRC as found centerline at the various nautical miles; FLG-10 is FLG centerline at 10 NM (18.5 km). Following is a brief summary of the flight inspection findings;

- The flight Inspection data recorded during this trip verified and established locations of the previously observed PRC LOC Runway 21L SIS in the FLG Runway 21 approach area (i.e. around the Mount Humphreys area).
