More Traps and Pitfalls

Stefan Jagieniak, *Aerodata AG, Germany*

ABSTRACT

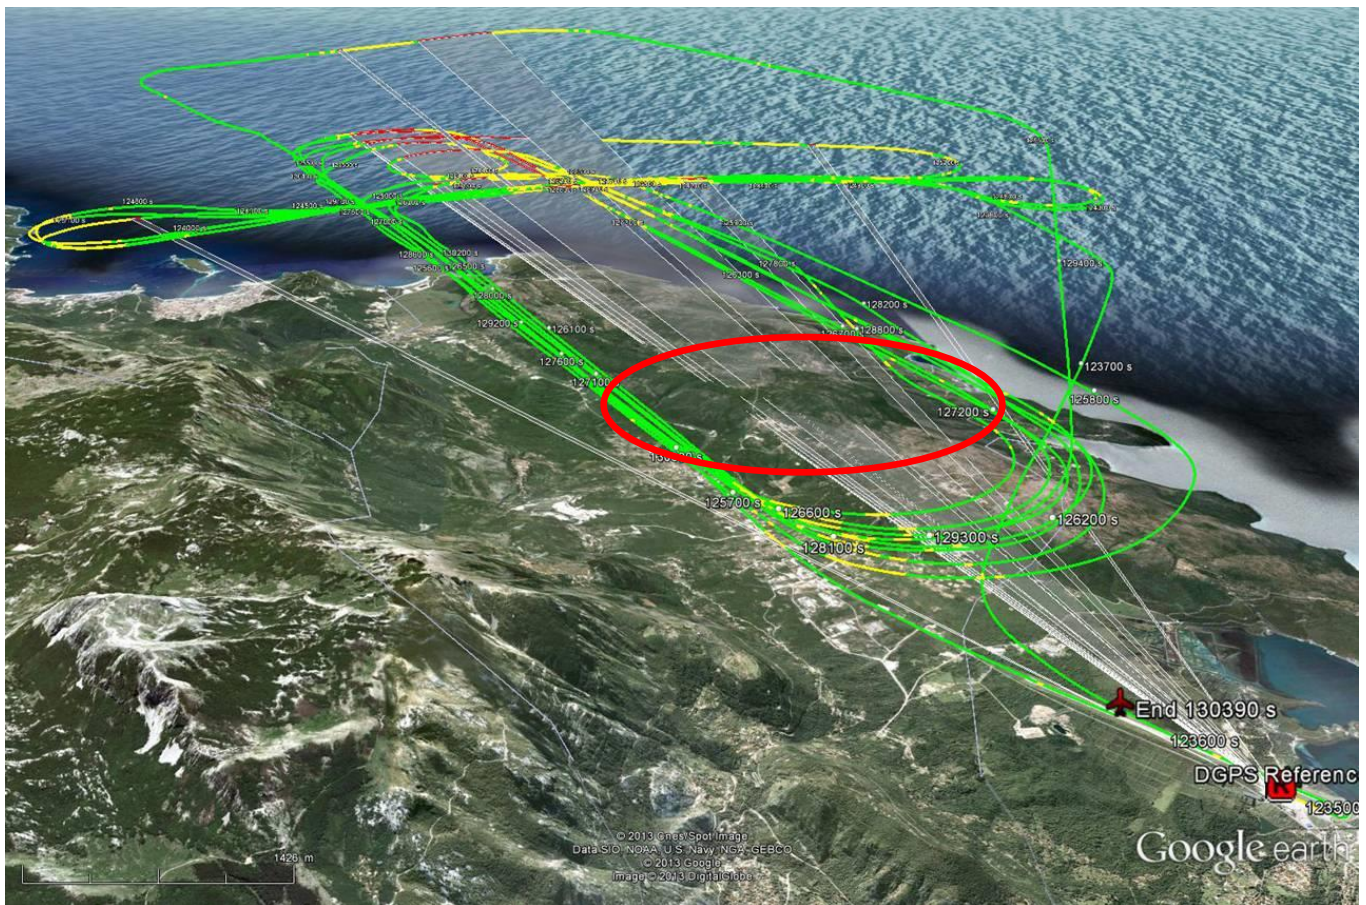
Figure 1: DGPS Status during an ILS Inspection

Figure 1 shows the PDGPS status during an ILS commissioning. The color code indicates the GPS quality. The operator was not satisfied with the availability and provided the data for analysis.

Red areas show telemetry interruptions. At 20 NM distance, a height of 2000 ft gives an elevation angle of only 0.9° . Any obstacle like a building, a hill, a mountain will prevent a line-of-sight connection. This is necessary for full integrity and accuracy information. It is important to keep in mind that even such low obstacles at 0.9° have to be avoided when selecting the ground location of the DGPS telemetry uplink antenna. Satellite-based DGPS like SBAS or TerraStar overcomes this issue, but may have drawbacks concerning license cost and proven integrity.

The red ellipse highlights the mountain peaks interrupting the line-of-sight.

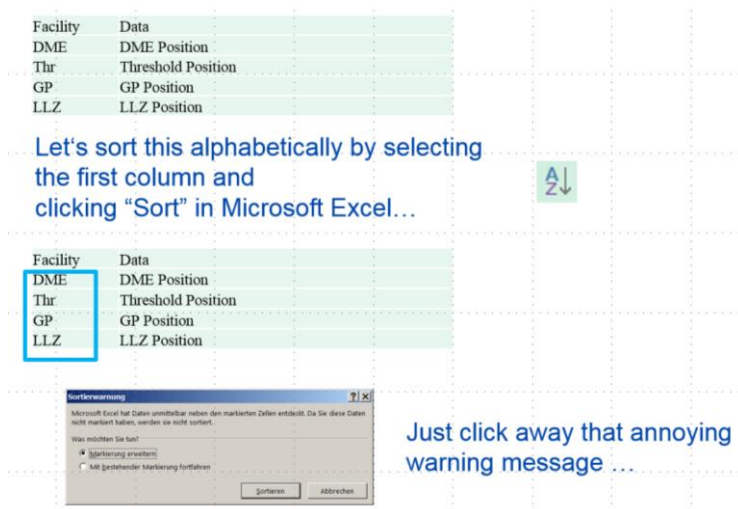
Figure 2: Table column selection and sorting

Who reads these messages when being under time pressure? In this case obviously nobody. It warns about the selection of only the first column. That results in only the first column being sorted and the other columns remain unsorted. Probably this message might have been not present in an older software version. This resulted in sorting of the idents column only and garbling the assignment to the Lat, Lon, Alt coordinates, as depicted in Figure 3.

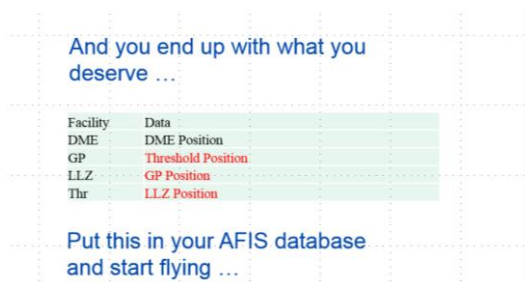
Figure 3: Ignoring warning messages may give you this

Google Earth showed the GP on threshold and the threshold at the localizer position. This pretty much explained the strange computation results. But how could that ever happen? Let's have a look at the table sorting user interface of a well known office application:

The recommendation to crosscheck the data with e.g. google earth was not possible due to lack of internet connection at the airfield. The survey data remained unquestioned. There was also no threshold lineup check with the aircraft.

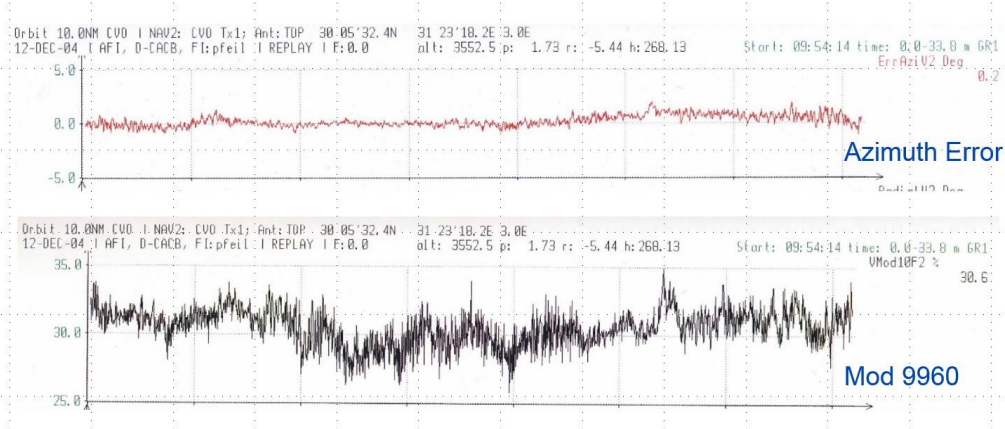
Figure 4: VOR azimuth error and modulation from RNA-34AF

Figure 4 looks pretty normal, perhaps a little bit noisy.

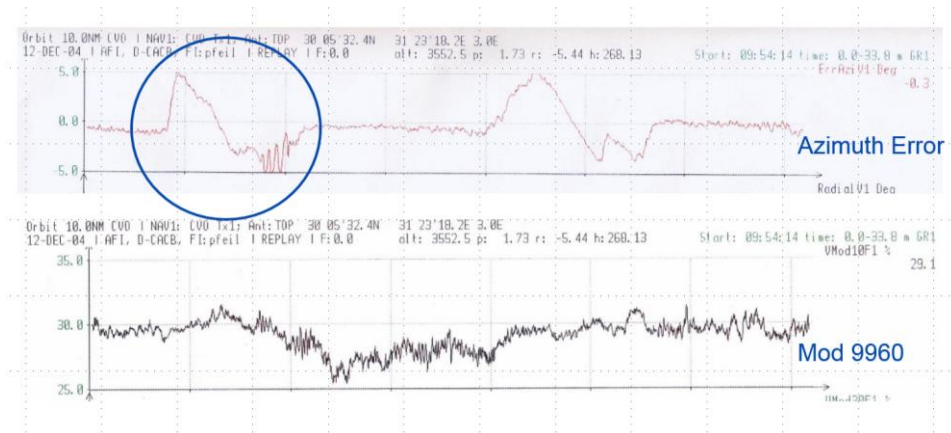
Figure 5: VOR azimuth error and modulation from AD-RNZ850

Figure 5 is from the same run, same input, with a different FI receiver. Now there is a significant azimuth error at two positions.

The well established and known receiver showed rather normal data with only minor glitches. The flight inspector intended to sign off the VOR as fully serviceable. The alarming systematic azimuth error of about 6° and the strong deviation ratio break in of about 13 instead of 16 were assigned to the – at that time – new receiver type which was not trusted.

Finally the problem was revealed as a cable swap of antenna segments on ground.

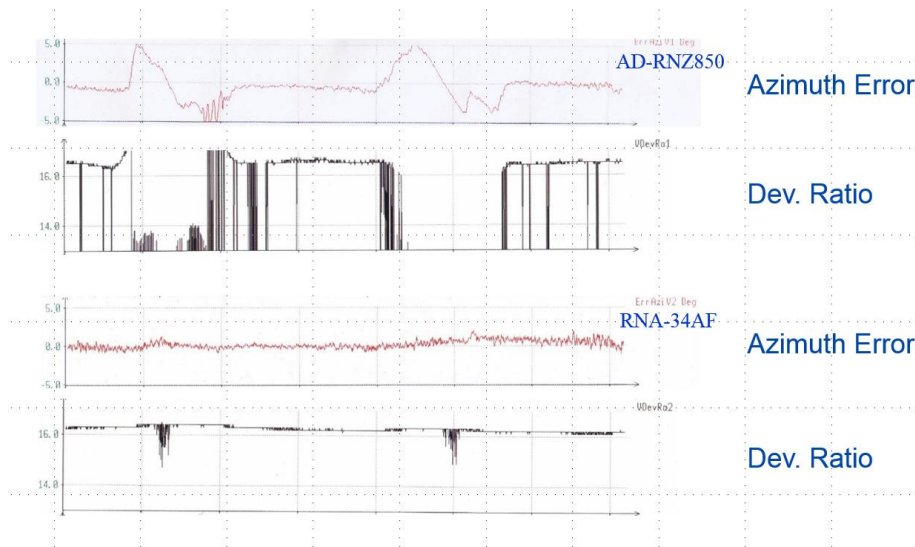
Figure 6: VOR azimuth error and deviation ratio in comparison

Also the deviation ratio has significant outages in the second graph which were not seen before.

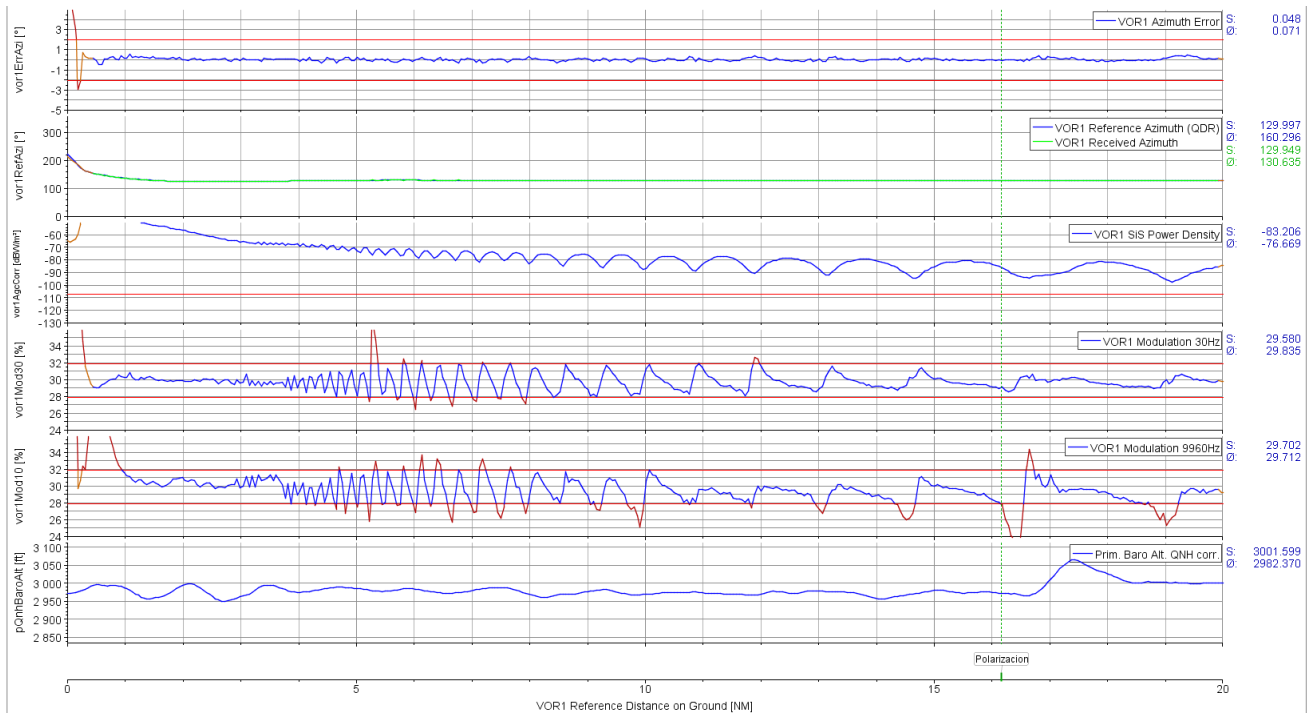
Figure 7: VOR radial showing typical multipath pattern

There was a customer's request to explain different signal-in-space (SiS) results at a VOR radial when using top and tail VOR antenna. The first reason was rather straightforward. The VOR SiS graph shows typical "bouncing" effects when flying over water, which was the case, as Google Earth revealed.

The VOR was located at some dozen meters elevation at the oceans shore.

The signal shows typical multipath, exactly as in simulation.

The inbound radial uses the top antenna. The outbound radial uses the tail antenna.

Dependent on the location at the aircraft, top and tail antenna show different amounts of multipath, because the reception situation is beyond specification and the field changes rapidly with location.

The recommendation was to either relocate the VOR or install antenna modifications to reduce the multipath.

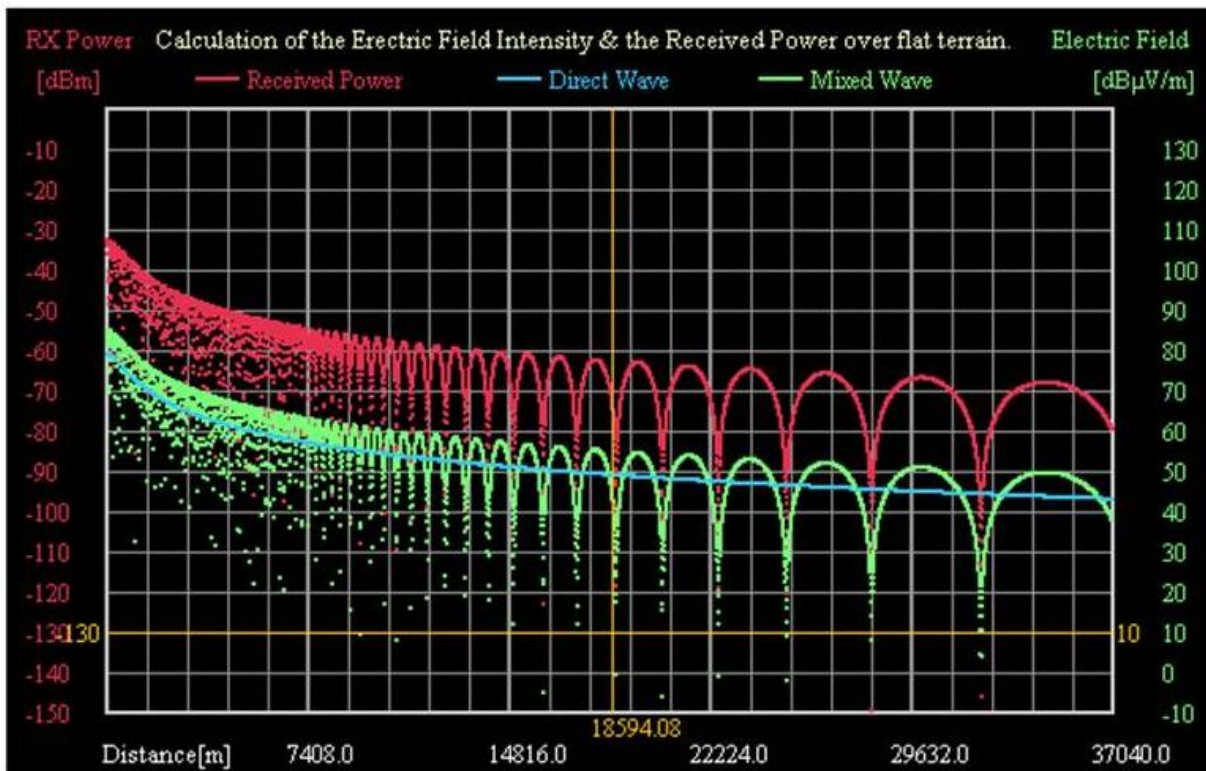
Figure 9: Numerical SiS Simulation using of the actual VOR geometry

Simulation and real data nicely matched proving that the effect was related to the facility.

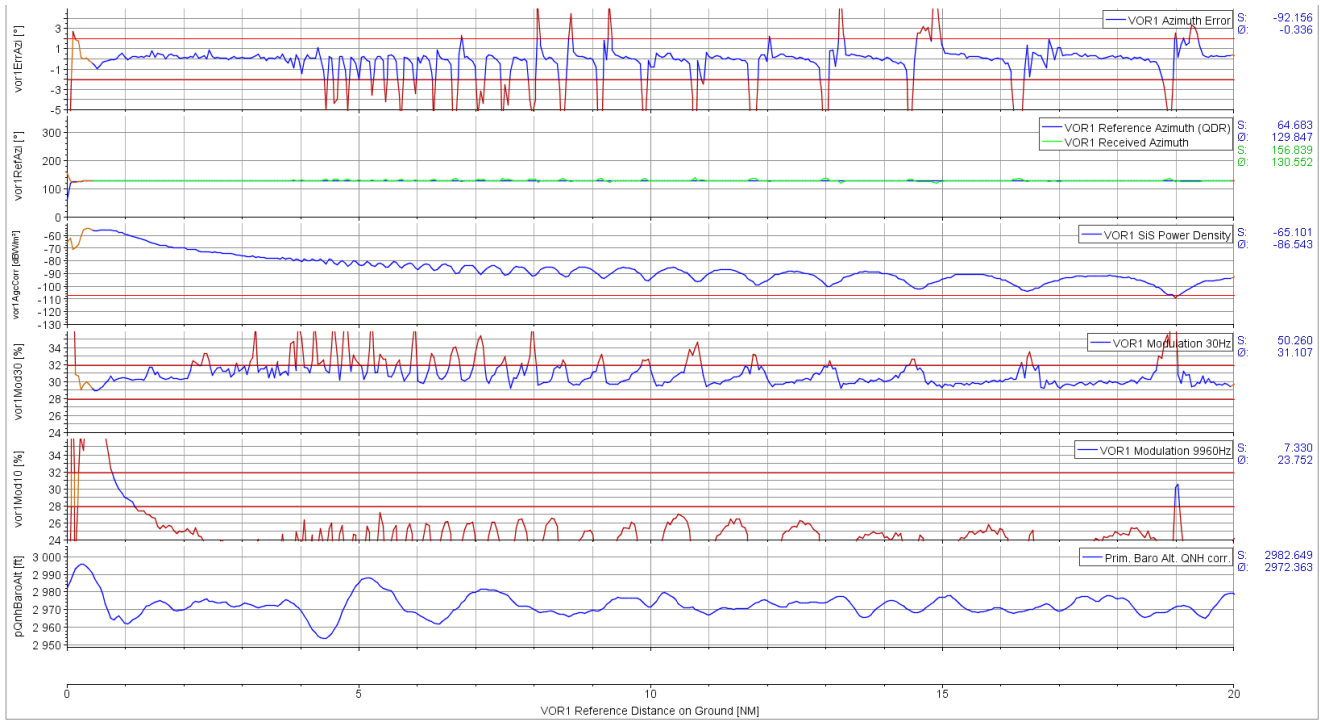
Figure 10: VOR radial with glitches and low 9960 modulation

On the same flight, which already showed the “bouncing” SiS indicating multipath as in the training books, a second, independent effect appeared: On some profiles, the 9960 Hz modulation was significantly weak, the 30 Hz modulation and the azimuth error had strange peaks going out of tolerance (Figure 10, Figure 11). This happened at the top antenna only. The crosscheck using the tail antenna was good and the effect was independent of the receiver (Figure 12).

This gives a strong indication that the antenna is the root cause. But how can it impact the 9960 Hz modulation despite the SiS being fine? The spectrum analyzer allows a deeper look into the antenna characteristic by visualizing the VOR video.

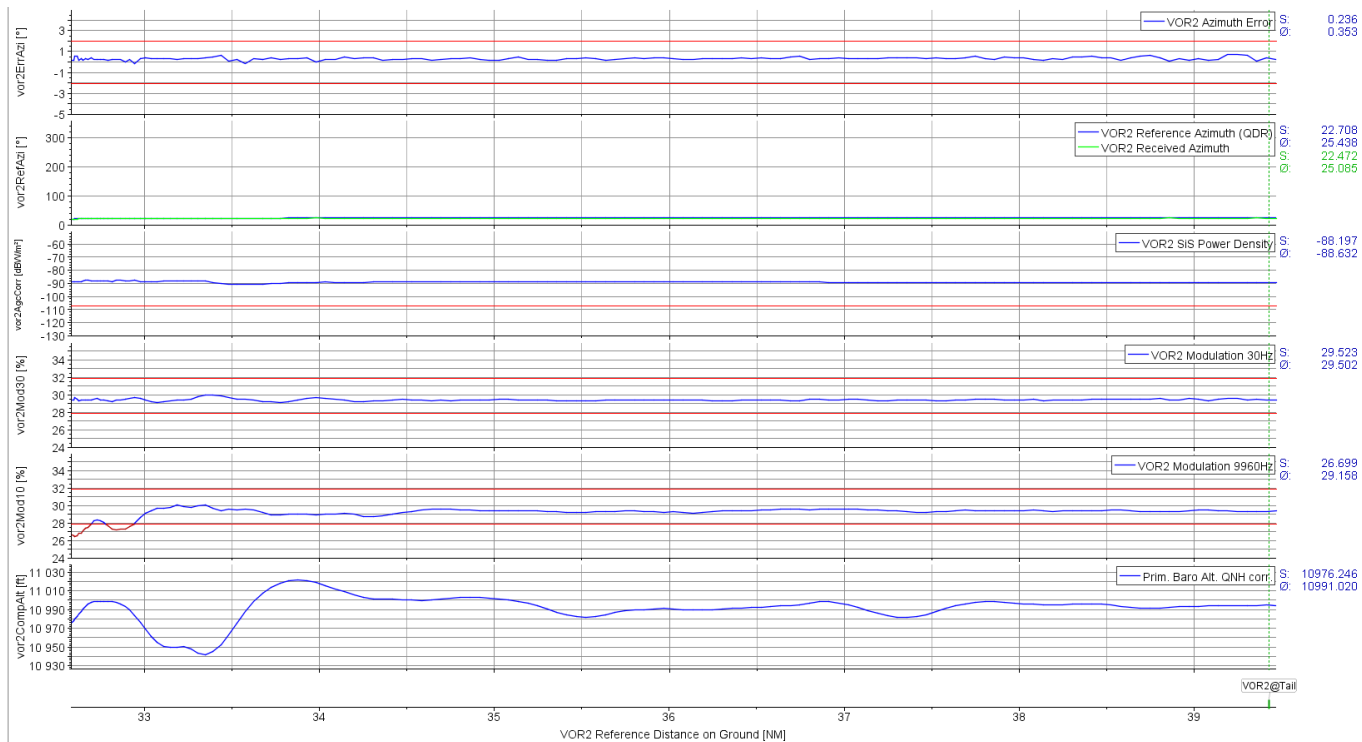
Figure 12: Everything is fine with the tail antenna

As the tail antenna provides a reasonable result with both receivers, the effect is neither correlated with the ground facility nor the flight inspection receivers.

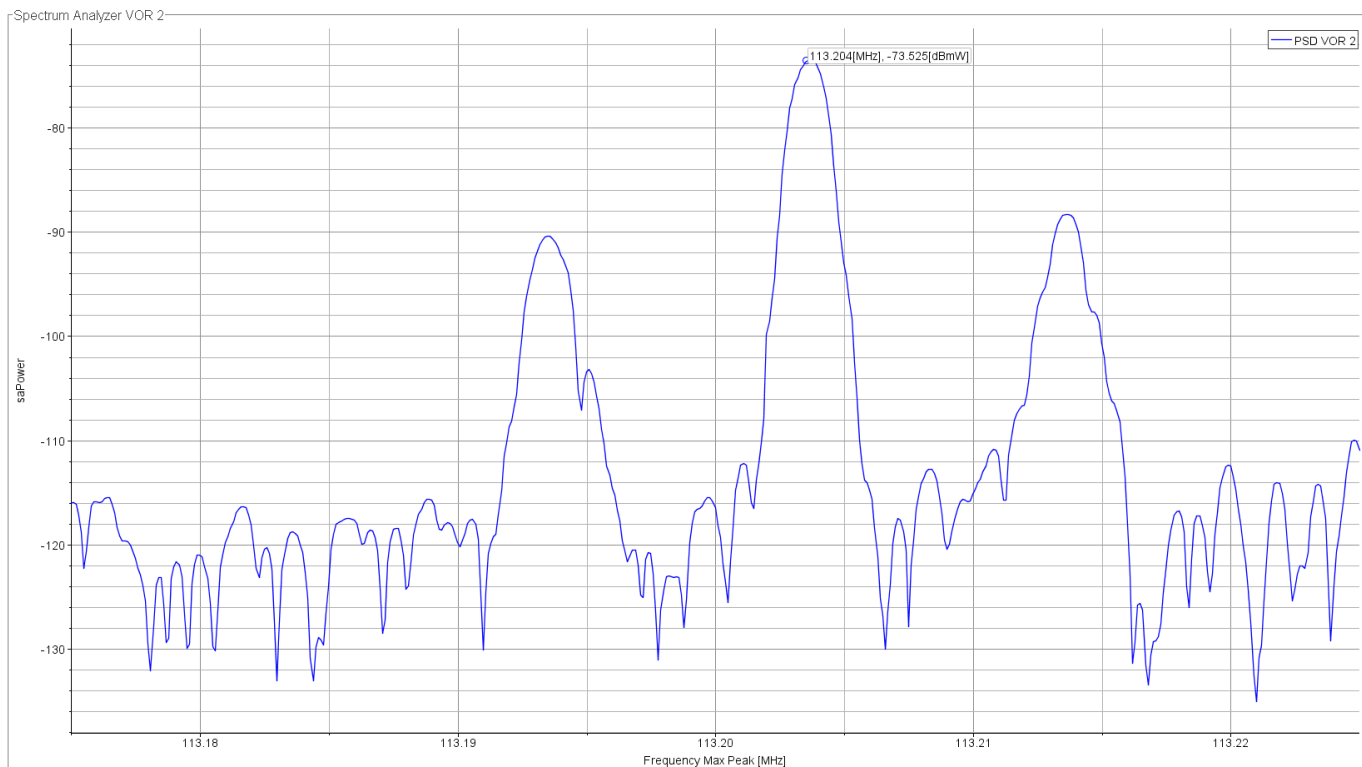
Figure 13: Spectrum analyzer plot of tail antenna

The normal VOR video in Figure 13 shows a peak at the carrier frequency and two smaller peaks at carrier +/- 9960 Hz modulation.

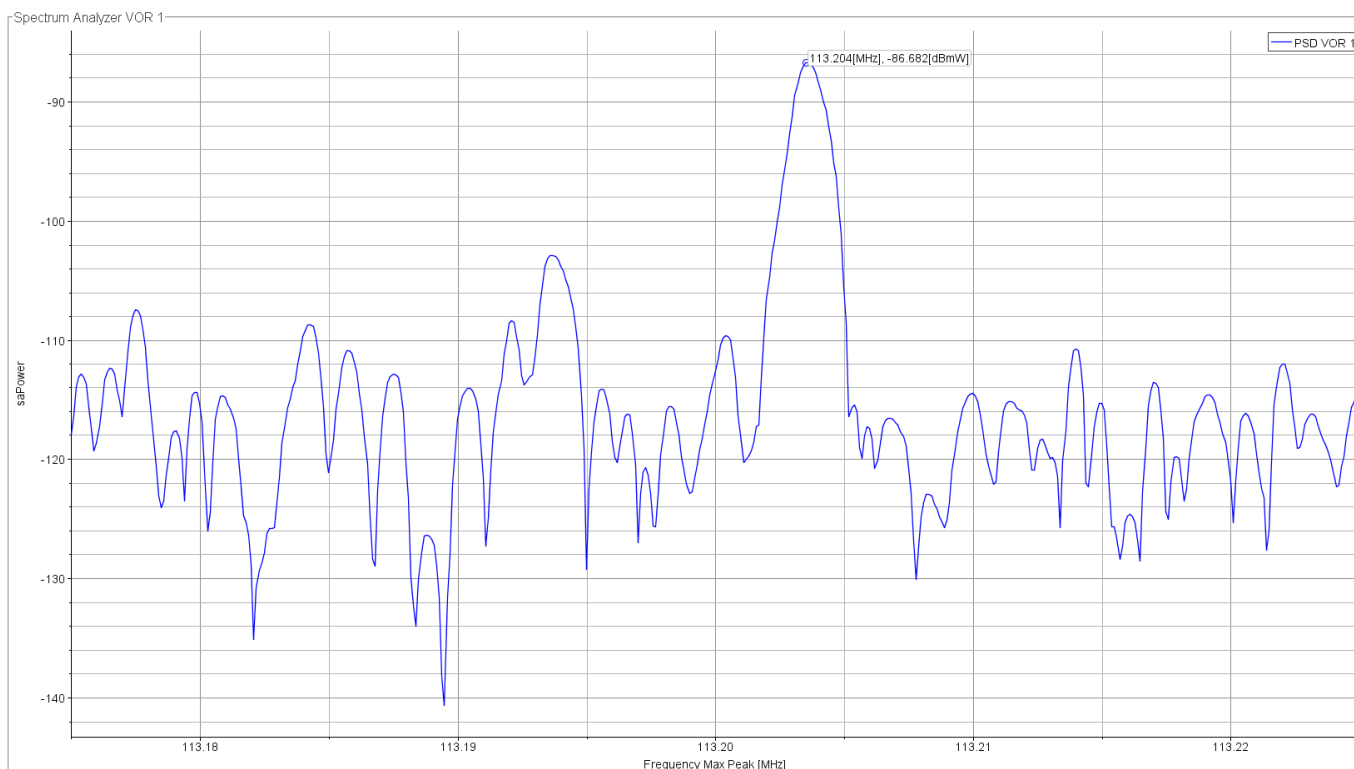
Figure 14: Spectrum analyzer plot of top antenna

Figure 14 shows a strongly distorted VOR video, obtained from the top antenna. The modulation peaks are almost gone. No wonder, that the receiver cannot identify 9960Hz modulation and a very small value is indicated.

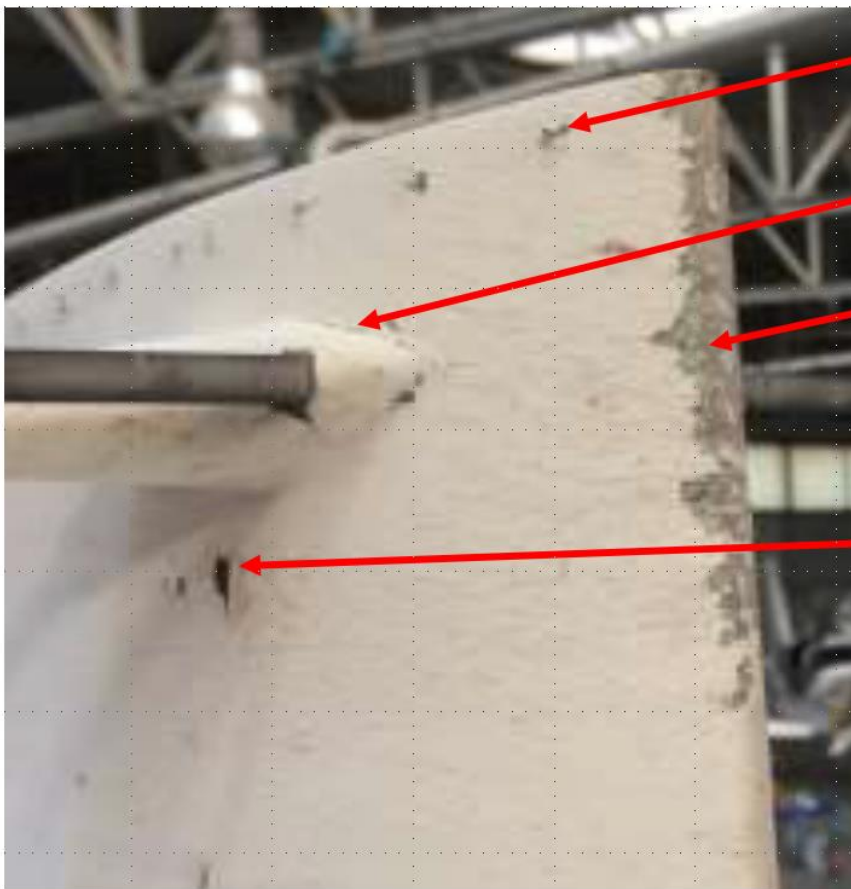
Figure 15: Visual Inspection of the Top Antenna

Rivets

Cracks

Wear and tear
down to raw
glass fibre, no
paint anymore

Paint gone

Figure 15 indicates a poor mechanical status of the top antenna and already indicates a due exchange.

- The FI console was under regular maintenance
- The aircraft was under regular maintenance
- The FI antennas were not checked at all for 10 years.
- Maintenance responsibility for FI antennas was not clearly defined.

The antenna was exchanged. It was recommended to revise the maintenance plan to include the FI antennas.

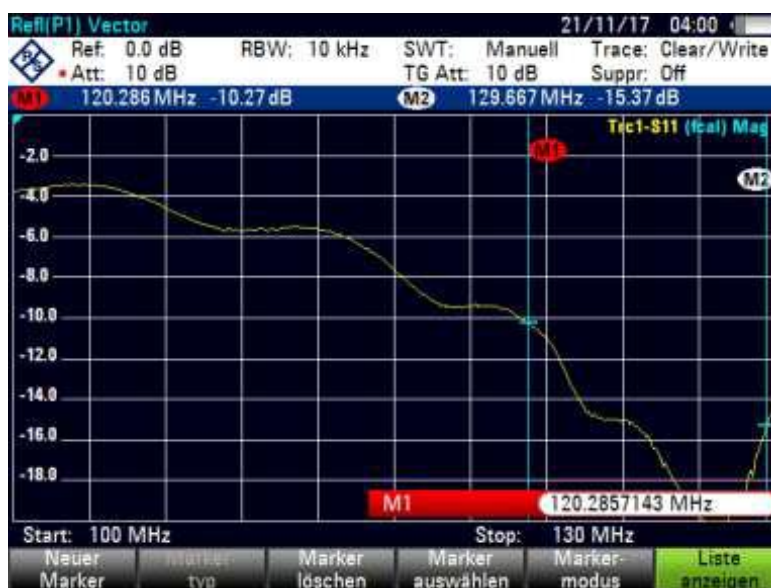
Figure 16: VSWR plot of top antenna

The antenna was checked with a “reflected energy versus frequency” test, also known as “VSWR” test.

This antenna had a center frequency outside the NAV band, at about 128 MHz.

The reflection, shown in “dB” unit, is far outside the standards over the full NAV band.

This explains weak AGC and modulation, but there is even more ...

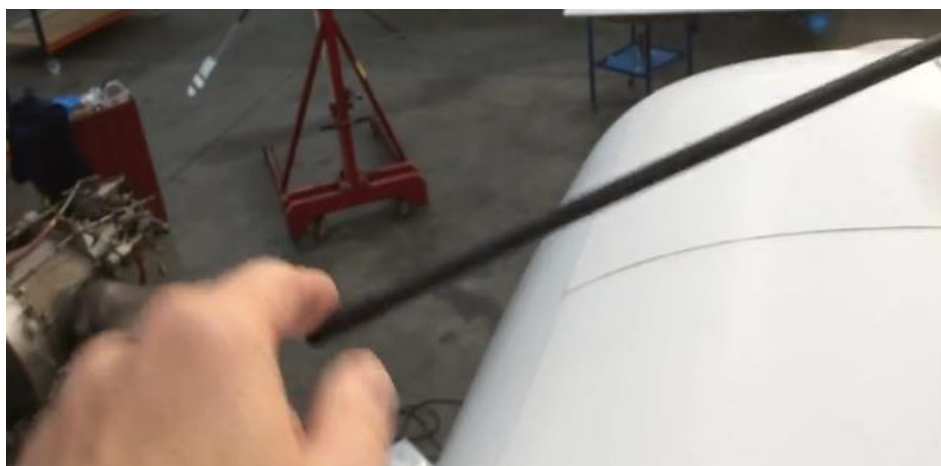
Figure 17: Magic Finger performing mechanical Test

It was expected, that this antenna may also have an “intermittent contact” problem inside.

This was tested by mechanical vibration on the radiating elements.

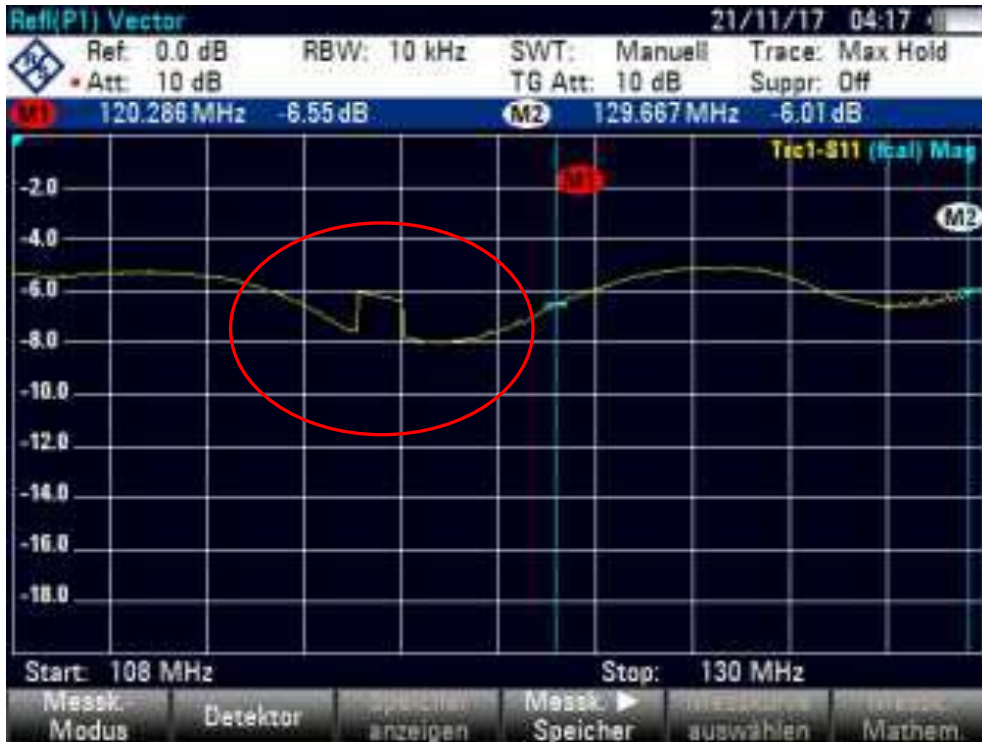
Figure 18: Glitch proving intermittent electrical disconnection

While the manually forced vibration the reflection plot was monitored, and as short-time spikes showed up, a mechanical intermittent contact was identified.

Crack sound was also on the audio. Funny enough, the GP signal was still fine.
