# Elimination of ILS Navigational HMI in the Operational Environment

By: Mickey Lindecker FAA, AJW143

# Investigation of PRC ILS SIS Around Mount Humphreys

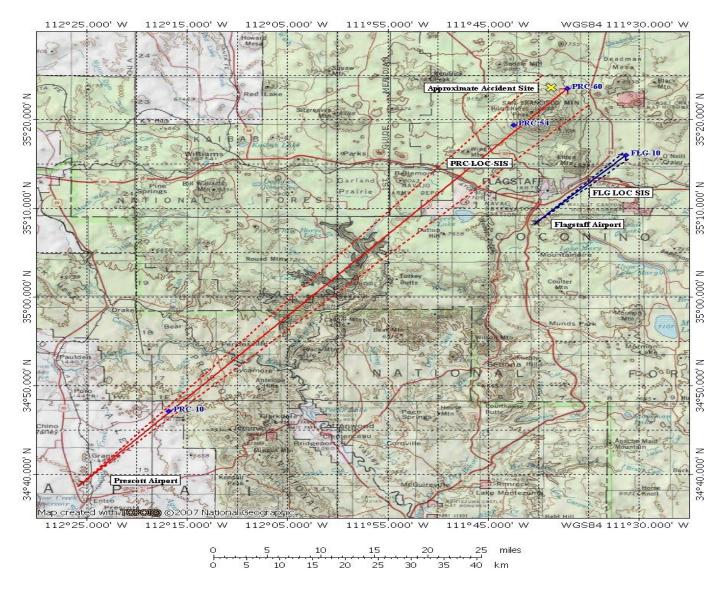
#### Prescott and Flagstaff Localizer Signal-In-Space

- Engineering request for Flight Inspection check of PRC ILS Signal-In-Space (SIS) around and behind Mount Humphreys, approximately 65 NM.
  - Run Sheet developed.
  - Both PRC and FLG SIS examined.
  - PRC SIS examined along entire 65 NM path to Prescott.
- PRC ILS SIS found low but usable within 1° and 1.5° of centerline at 10,000 ft (3,048 m).
- PRC ILS centerline found flyable at 13,500 ft (4,115 m).

- PRC Runway 21L LOC SIS exist in the FLG Runway 21 approach area, around and in a direct path with Mount Humphreys.
- That the ILS "HMI" condition exist as a result of unanticipated ILS installation circumstances.
- If utilized by a pilot during IMC and IFR can lead to deadly consequences.
- The risk of this ILS HMI condition is considered low by this author but not zero.
