Investigation of DME Multipath Propagation

Mitsuhiko Maruhashi

Flight Inspector
Japan Civil Aviation Bureau
Tokoname-City, Aichi, Japan
Fax: +81 569 381350
E-mail: maruhashi-m46ce@mlit.go.jp

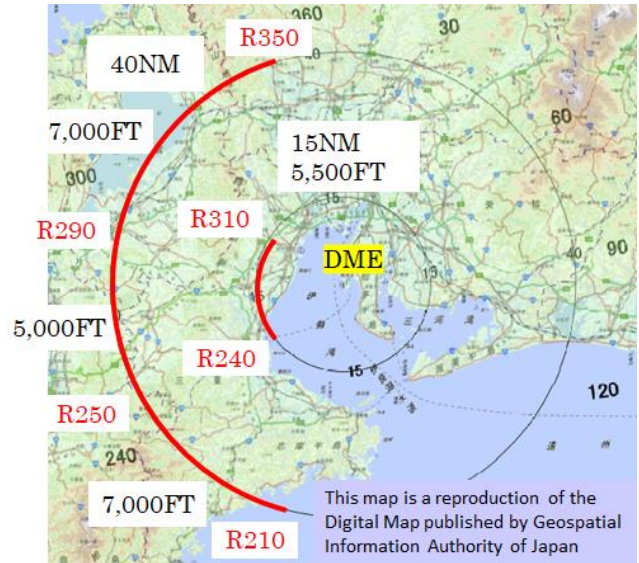
Figure 3. Flight Route

DME unlocks were observed in the west side of orbit flight when the VOR/DME ground facility was renewed. Figure 3 shows the flight route of 15NM and 40NM orbit. The red lines show the part of DME unlocks.

- Orbit 15NM R240-R310 (5,500ft)
- Orbit 40NM R210-R250 (7,000ft)
- R250-R290 (5,000ft)
- R290-R350 (7,000ft)

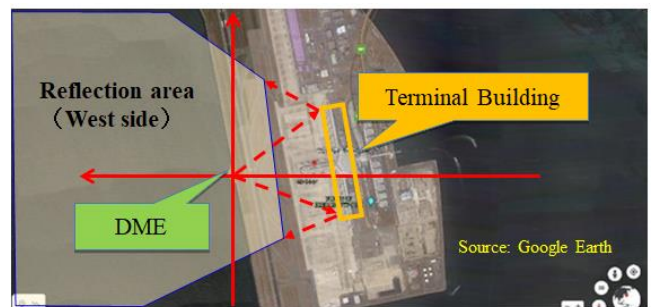
Figure 4. Estimated Reflection Area

As a result of the subsequent investigation, it was found that DME unlocks occurred because the reflected radio wave from the terminal building became stronger due to the change of the DME antenna specifications after the renewal.

Figure 4 shows the estimated reflection area that reflected by the terminal building. This area was approximately matched in the west quadrant where DME unlocks were observed.

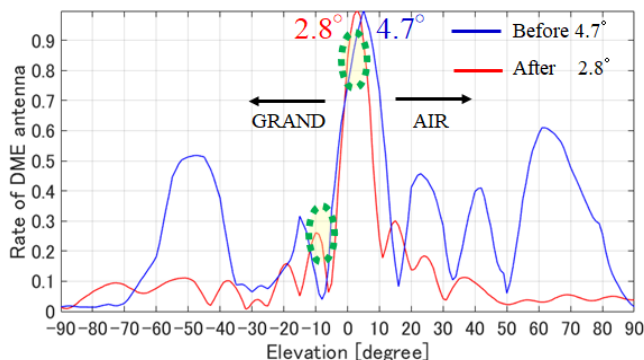
Figure 5. Comparison Chart of The DME Antenna Radiation Pattern

The radiation peak angle of DME antenna had changed from 4.7 degrees to 2.8 degrees after the renewal of its DME ground station. Figure 5. shows the comparison chart of the DME Antenna Radiation Pattern before and after. The radiation RF level around 0 to 1.4 degrees, which is directly reflected by the terminal building, became stronger after the renewal. In addition, the radiation RF level (around 0 to -11 degrees), which is reflected on the ground and then reflected on the terminal building, also became stronger after the renewal. As a result, DME unlocks occurred.

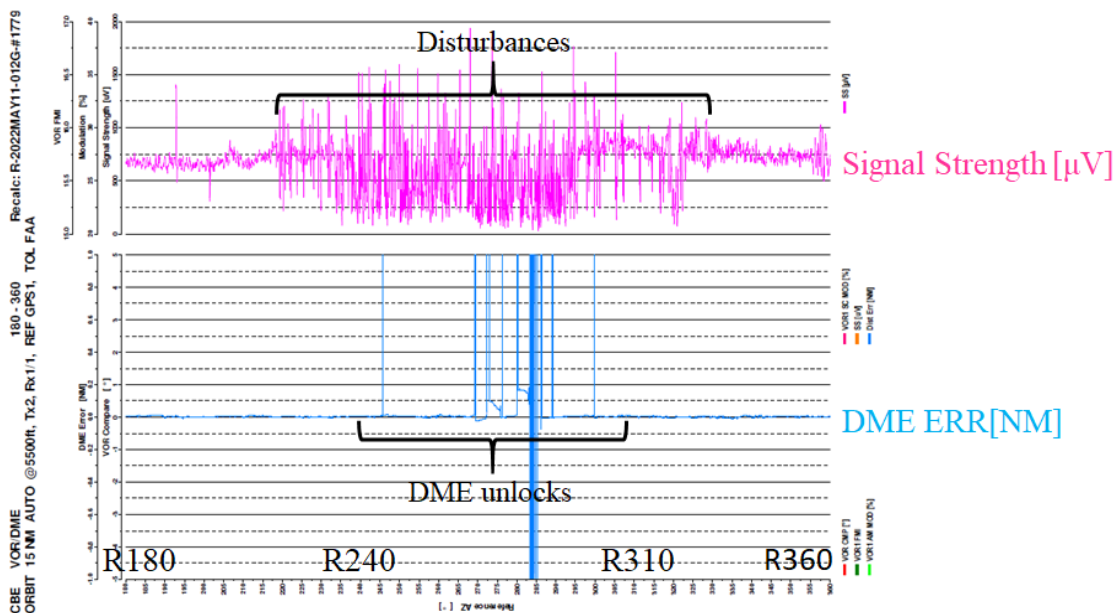
Figure 6. After DME Renewal

Figure 6 shows the flight inspection data of 15NM orbit flight after DME renewal. The magenta line shows the DME signal strength, and the blue line shows the DME range err. DME unlocks were observed between R240 and R310 and also, the signal strength was disturbed over a wide range.

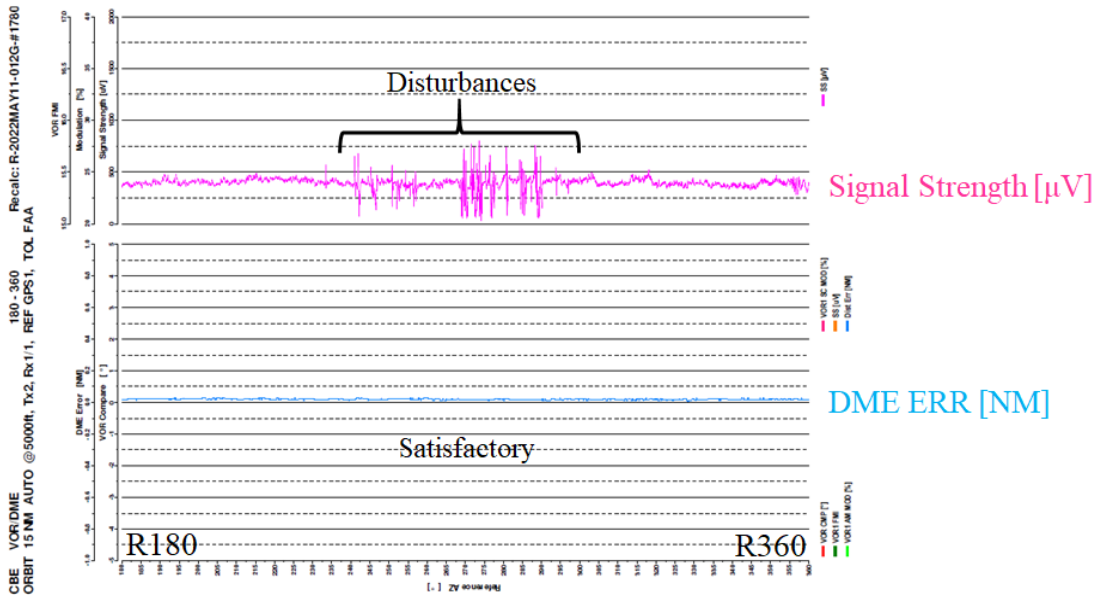
Figure 7. Before DME Renewal

Figure 7 shows the flight inspection data of 15NM orbit flight before DME renewal. The DME range was satisfactory, but there were some disturbances in the signal strength.

This means that DME unlocks were observed only after DME renewal. On the other hand, the disturbances in signal strength were found both before and after.

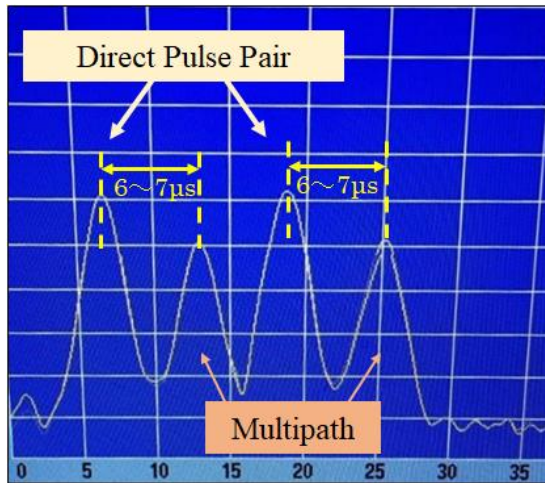
Figure 10. DME Reply Signal

Figure 10 shows the analysis result by the DME pulse analyzer of RF signal recorded during investigation flight. It was observed that multipath was mixed between the 12μsec direct pulse pair. The multipath was received with an intensity of about 80% of the direct pulse pair, and the reply signal could not be identified under this condition. From this analysis, it was found that the DME signal was strongly reflected by something, which caused DME unlocks. The multipath had a delay of 6 to 7μsec from the direct pulse pair. This delay is equivalent to 1,800 to 2,100 m in distance conversion.

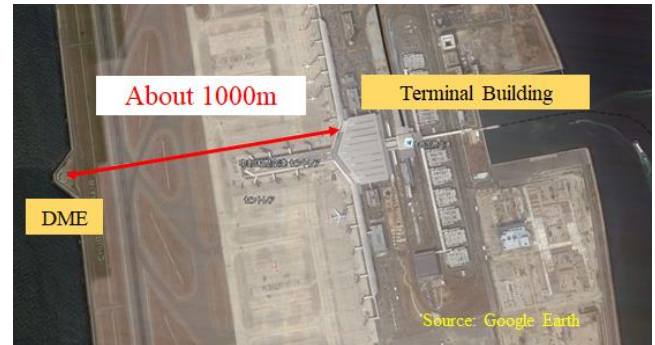
Figure 11. Distance between DME ground station and terminal building

Fig11 shows that the distance between the DME and the terminal building is about 1,000m, which means the round-trip distance is about 2,000m. As this number

matched the conversion distance of 6 to 7μsec, it was highly possible that the terminal building was the cause of multipath.

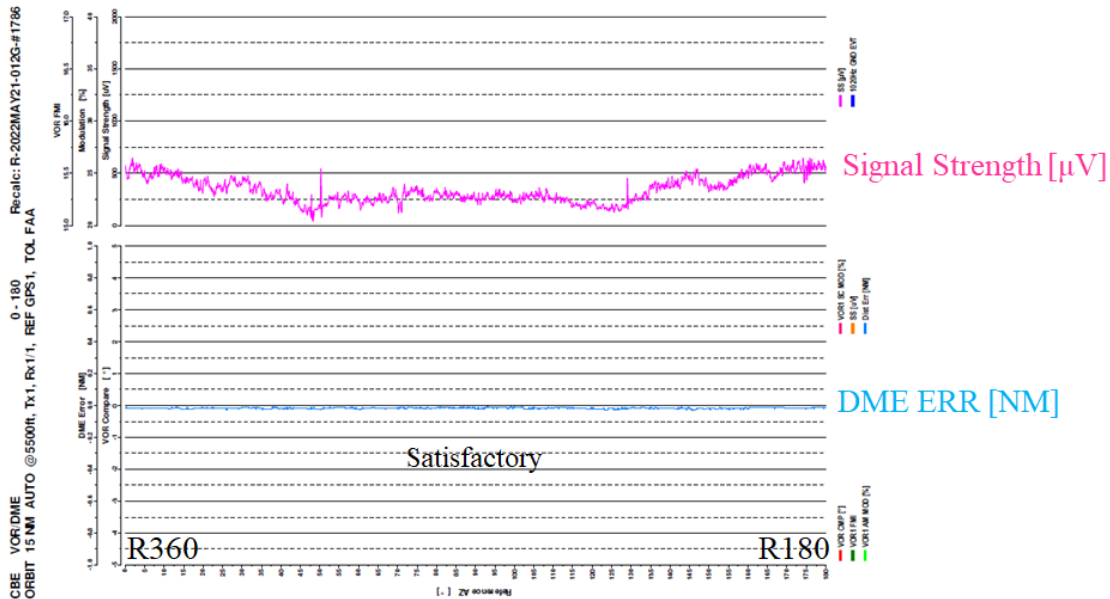
Figure 13. East Side of Orbit Flight

Since the radiation pattern in the east side was suppressed, it was necessary to inspect the performance in that side. Figure 13 shows flight inspection data of 15NM orbit in

the east side. The signal strength was about half of that before the antenna replacement, but the DME range was satisfactory.
