Detection of aeronautical frequencies jamming

Direction de la Technique et de l'Innovation
Sous Direction Systemes Opérationnels
Département 2 Contrôle en vol des aides radios.

ABSTRACT

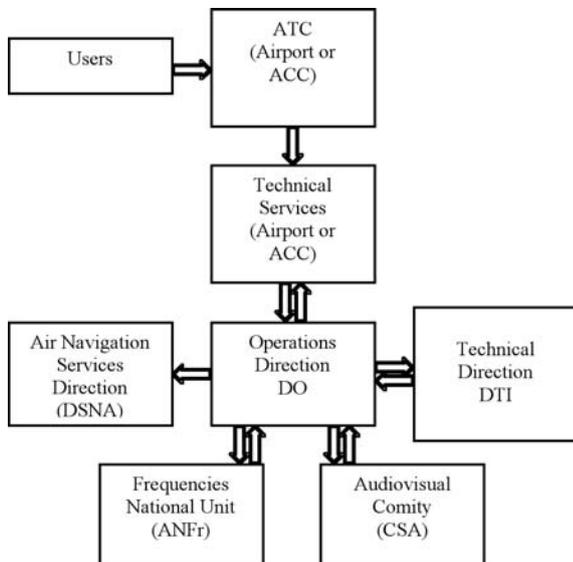
Figure 1 : Services taking part in the struggle against frequencies jamming

Figure 1 schematically describes this organization.

In the core of the organization, is the DO (Operations Direction). They centralize and coordinate the different actions. Especially the DO will classify the cases, set priorities and decide any air operation.

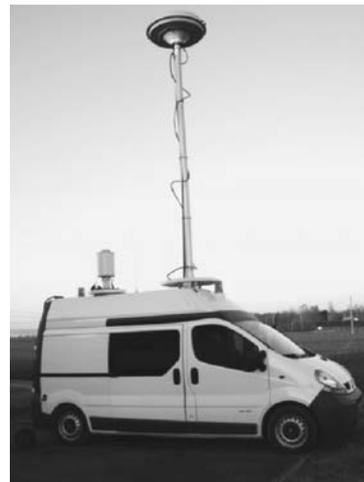
- For a couple of month, DTI has acquired a car and a trailer specifically equipped for detection of jamming and localization. They have been equipped with a wide band direction finder and a synthesized receiver.

The two systems are regularly used on sites (airports for example) by local maintenance or DTI operators.

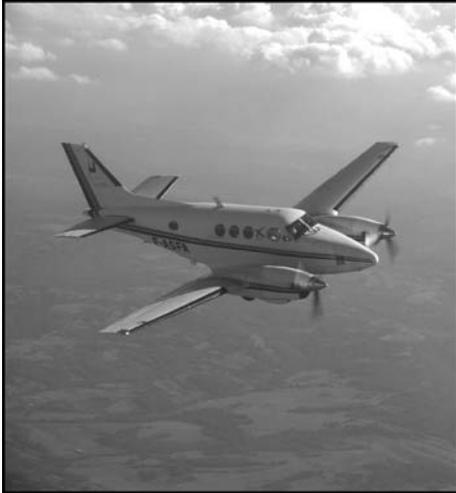
Figure 2 : F-ASFA : « JAMMING ZERO ONE »

The Beech 90 F-ASFA is dedicated to detect and localize jammings and disturbances affecting the aeronautical frequencies.

In this aircraft is, in particular, implemented a VHF and UHF direction finder for localization.

The architecture of the interference search bench is based on this DF and on a measurement receiver.

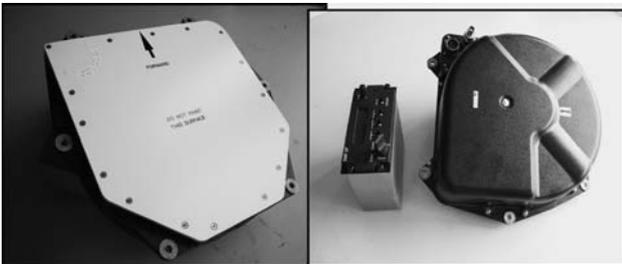
Figure 3 : MDF-124F(V2) antenna and its control unit

In order to fit the equipment onto the aircraft, a limit had to be made on the size and bulk of the antennae which were only compatible with the Doppler direction finder principle. Unfortunately, this principle is not the best in terms of precision and sensitivity. The precision is decreased due to the smaller size of the aerial and the resulting sensitivity is weak. This defect is inherent to the Doppler system, which requires the incident signal to be processed in order to extract the relative bearing. However, the first tests carried out using the TB-20 showed that even the basic version of the MDF-124 was able to satisfy the requirements. These tests generally showed up a certain number of points that needed to be improved.

DTI therefore requested Rockwell Collins France to make certain modifications, which resulted in a new version of the MDF-124F, specific to DTI; this version, named MDF-124F (V2), is now fitted in the Beechcraft 90. The sensitivity was improved by adopting a new reception stage with double frequency change. The rejection of adjacent channels was also increased, in order to prevent signals that are close in frequency from disturbing the measured signal. This parameter is essential since, by definition, we are working on weak signals in a band where there are many "legitimate" transmissions (at least, seen from an aircraft in upper airspace). It is therefore important to be able to separate correctly the signal to follow from signals which are close in frequency. The other improvements concerned the width of the intermediate frequency filter that can now be switched between different values, and on the frequency selection increment, which was changed from 25kHz to 12.5kHz. This might seem high compared to laboratory instruments, but it must not be forgotten that this direction finder was initially designed for use on regularly spaced aeronautical frequencies, and was never designed as a measuring device or as research equipment. The technology used did not allow smaller spacing than this.

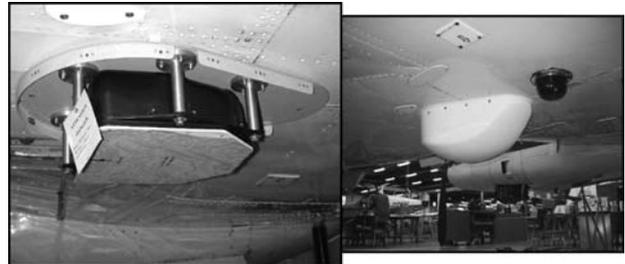
Figure 4 : The direction finder antenna fitted under the aircraft

The MDF-124 is designed in such a way that once it is installed; the antenna is flush with the skin of the aircraft. The exposed part outside the aircraft is therefore reduced to a minimum. However, this requires major piercing that is incompatible with the structural resistance needed for a pressurised aircraft such as the Be-90. Fitting it under the radome was therefore the only viable solution. The assembly kit was made by SOCATA and installed by the SEFA workshops in Castelnaudary during the aircraft modification works. The various tests carried out before the aircraft was put into operational service showed that this type of installation did not in any way detract from the direction finder operation, or alter the flight qualities or performance of the aircraft either.

An aircraft used as a carrier for a measurement direction finder is far from being the ideal environment. Indeed, the propellers create large masks on either side of the lubber line. The various antennae tuned on VHF frequencies are also potential disturbances. In addition, the VHF transmissions of Air/Ground communications risk saturating the reception stages of the direction finder. The antenna associated with the second on-board VHF therefore had to be moved as it was too close to the place planned for the MDF-124. This type of change systematically requires submission of a modification file and its approval by the appropriate authorities, which inevitably leads to delays.

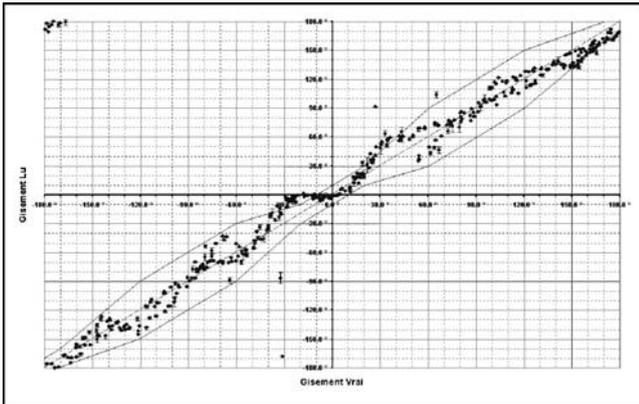
Figure 5 : MDF-124 Error Curve Measured Bearing =f(Real Bearing)

The first tests using the newly equipped Be-90 were carried out in October 2002 and showed that the aircraft and its interference search bench could begin without any delay. The sensitivity of the MDF-124 was measured to be -100dBm . At this sensitivity threshold, the precision is calculated to be $\pm 20^{\text{RMS}}$ (RMS: Round Mean Square). Of course, the quality of the measurements obtained increases with the level received. The error curve recordings showed correct operation enabling coherent vertical searches to be made in particular. More specifically, on the error curve shown in Figure 5, a dip can be observed in the area located between $\pm 30^\circ$, which characterises a slow reaction of the direction finder. This "over-stable" behaviour is characterised by variations of the indicated relative bearing which are lower than the variations of the real relative bearing. This distinctive feature, partly linked to the antenna installation, is a sort of integration of the information on the relative bearing, which makes it easier to read and exploit. The validation tests of the MDF-124/Be-90 couple also enabled a methodology for use during

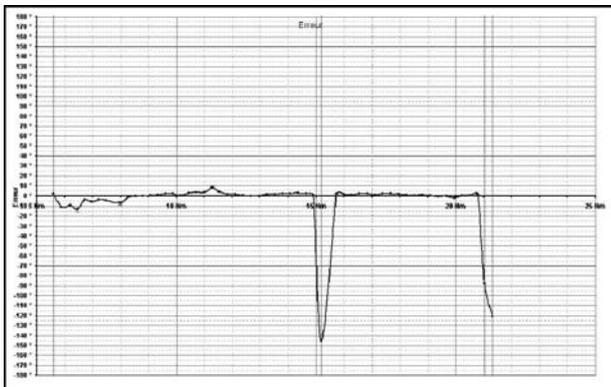
Figure 7 : Inbound Bearing Example

operational searches to be defined. Due to the functional characteristics of the system, the search for the origin of a disturbance is facilitated by tracking the direction finder measurements as closely as possible and adapting the trajectory to make one or more vertical passes over the site of emission. This pass is then confirmed by a sharp change in the direction finder bearing. Nevertheless, it remains possible to make abeam measurements of the bearing, although without the precision of a vertical measurement.

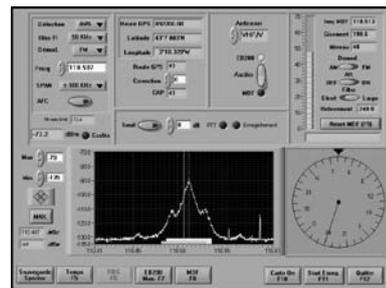
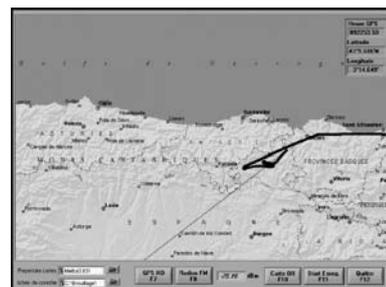
- The first one MELBA is designed for the control/command of the receivers and the acquisition of the different parameters and in particular to link GPS positions with goniometric plottings and signal level measurements. Integrated cartographic function makes operator job easier during the searching phase and the guidance phase to the source.

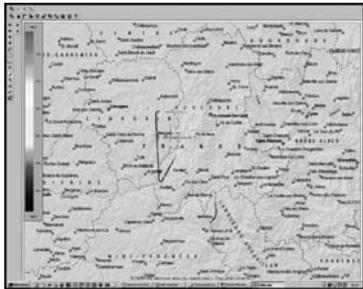
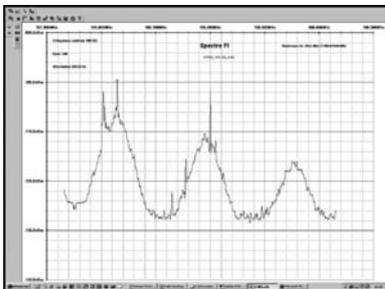
- The second software CARL is a complement of MELBA and is in charge of operating, replaying and processing of the different data recorded during the searching flights. These raw data are ponderated, the quality and the power level of the signal are processed and this allows to obtain from the different measures through a triangulation a localization area of the jammer. If the source of the jamming is a FM station, we can compare

directly this area of localization to a data base of more than 7200 FM stations and antenna in France to get a more accurate positioning and to reduce the investigation area for the final ground search.

All the data are automatically plotted on a cartographic background which scale is matched to the flight area.

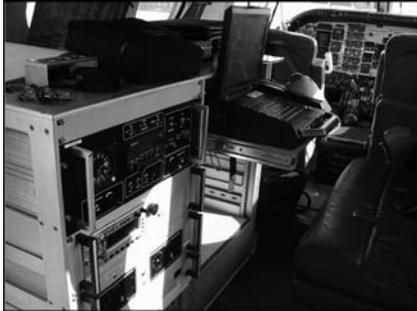
Figure 8 : Interference search bench installed on board the F-ASFA

The Be 90 interference search bench is based on these two means, the MDF-124F for localization and the EB-200 for detection and listening. Associated with this equipment are tunable filters enabling perfect protection of the EB-200 against the appearance of non-linear phenomenon in the entrance stages in the presence of strong fields, a GPS/GLONASS receiver for geographical localizing, a control and switching unit, and a ruggedized PC enabling central control of the various pieces of equipment. These are connected to the aircraft by a junction box which acts as an interface between the antennae (VHF and UHF for the EB-200 and the direction finder antenna for the MDF-124). This junction box also provides the power supply and the necessary parameters (synchronisation of heading and "push to talk" of the on-board VHF radios). All the equipment is conditioned to fit into 19" standard racks, enabling fast assembly and disassembly and the addition of specific devices in certain cases of specific interference on frequencies other than VHF. Most of the time these various pieces of equipment work on the PC with very user-friendly software that was developed by DTI.

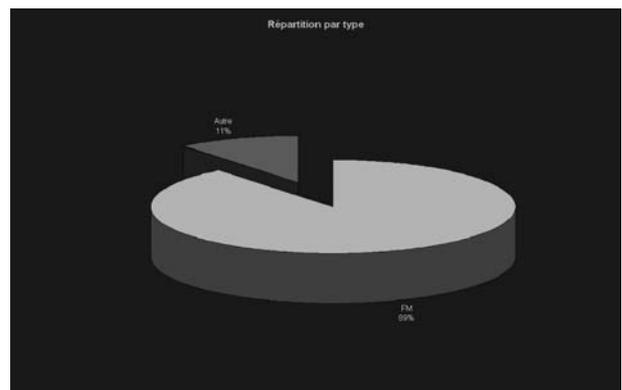
Figure 9 : Distribution by origin

Since 1998, the operations using DTI aircraft were able to resolve 70 cases of interference that were either reported or simply observed during systematic search campaigns. The origin of 89% of the cases treated was an FM radio broadcasting service in the 88-108MHz band, and 34% of the cases were of foreign origin. Among these 70 cases, some of them required an operation using the Be-90. The following examples explain some of the most symptomatic interferences.

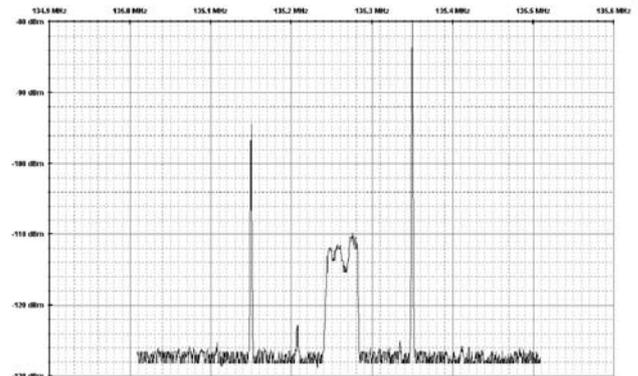
Figure 12 : Sector N ACC/SW Interference Spectra

perform a vertical search as the permit to fly limited the aircraft's maneuvers over French territory. Nevertheless, the specific character of this interference could be shown which, for once, was not caused by an FM radio, but by a parasite signal randomly moving on a band of 2MHz. This particularity explained the temporary aspect described by the pilots who had been confronted with this phenomenon.

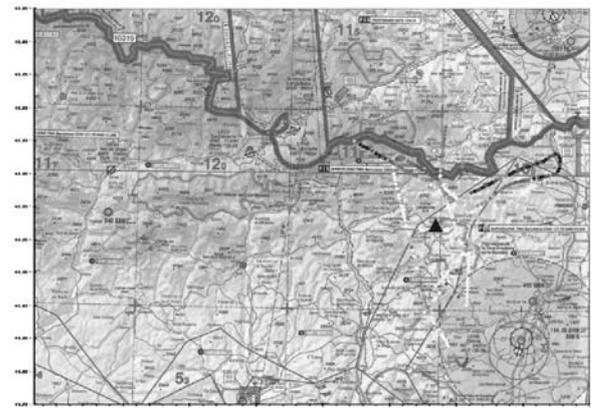
Figure 13 : Trajectories of interference search flights on 135.205MHz.

On 30 July 2003, the second search, this time with a normal airworthiness certificate, found the source located northwest of Gerona (Spain). The search was quite delicate, however, due to the mobility of this signal that needed many frequency changes on the EB-200 and direction finder to continue the measurement, which in addition, was quite disturbed due to the mountainous environment of the site. These different points prevented a good vertical pass over the site being made in spite of many attempts at different altitudes and from different angles of approach. The data recorded was nevertheless sufficient to calculate a reliable and precise triangulation of the interference. This position was confirmed later (within a range of 600m) by a team on the ground. The origin of this disturbance turned out to be an electrical drying system used by a manufacturer of conductor cables.

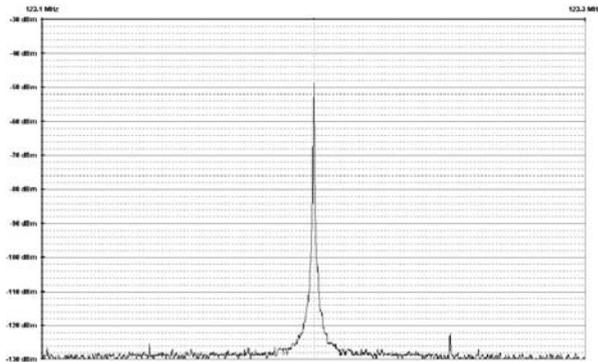
Figure 14: Muret, Nimes and Calvi TWR frequency interference

This case could have had more serious consequences if the jamming had lasted. It had been reported by three aerodromes using the same TWR frequency, 123.20MHz. The complaints mentioned a permanent background noise above a certain altitude, which varied depending on the place where the interference was perceived. The probable area where the source of interference was located was quite easy to determine because of the geographical distance separating the three aerodromes. The search flight plan was therefore defined in a triangle: Toulouse, Montpellier and

Perpignan. As expected, the interference was picked up quickly after taking off from Toulouse Blagnac and was immediately tracked by the direction finder. The first abeam station pass took place at FL170, then two vertical passes at 6000ft and 3000ft enabled visual identification of the source located at a military airfield close to Narbonne. As shown by the spectra recorded during this search (see Figure 14) it was a continuous wave emitted by some military VHF equipment, on which the push-to-talk automatic test system had remained stuck on transmission.

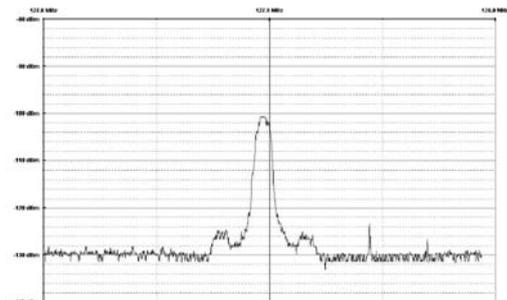
Figure 16 : Spectra of interference from a Spanish radio on an ACC/West frequency

A search to solve this case took place in August 2003 after complaints from ACC/West reported severe disturbances on 127.86MHz. As some crews had reported hearing music, it was fairly certain that the source would be an FM radio. This hypothesis, together with the experience of interference affecting the ACC/West's sectors of south Brittany/Bay of Biscay, led to a flight plan being filed to pass over Biarritz and continue to Bilbao (BLV VOR). Indeed, shortly after Pau, the interference was easily identified. The signal and its spectra confirmed that the phenomenon was in fact due to a fault in a Spanish FM station. The search continued until an excellent vertical pass was made, which enabled the site of the transmitting pylon to be located very precisely.

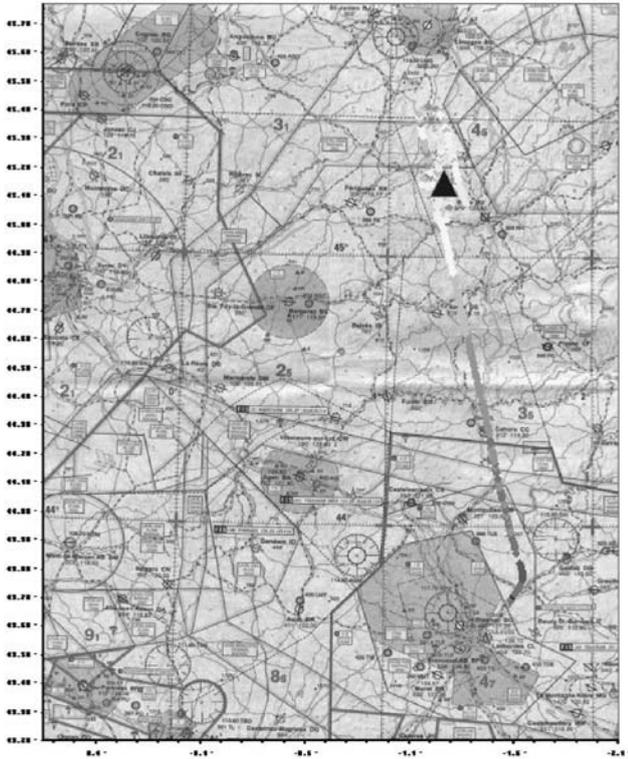
Figure 19 : Search on Clermont Ferrand APP frequency.

This example is typical of operations carried out the most frequently with the Beech 90. This assignment took place on 23 October 2003 and enabled identification of an FM radio beaming signals on 128.83MHz, a Clermont Ferrand approach frequency. The complaints at the origin of this search reported crackling and background noise on the approach frequency in the whole of the West/Northwest sector of its area of use. The initial flight plan was designed to cover this fairly large area. Very quickly after take-off, the disturbing signal was identified and easily tracked thanks to the co-operation of Clermont Ferrand air traffic control that had liberated the frequency. A vertical pass was made at very low altitude, which allowed a visit by the ANFr the very next day. It turned out to be a transmitter of the "Vallée de Vézère" radio station in Dordogne, emitting 1kW on 104.40MHz. This radio could not be identified during the search, as the parasite signal more like a continuous wave than an FM modulation. Apparently the fault originated in a frequency synthesizer generating parasite rays with very little FM modulation.

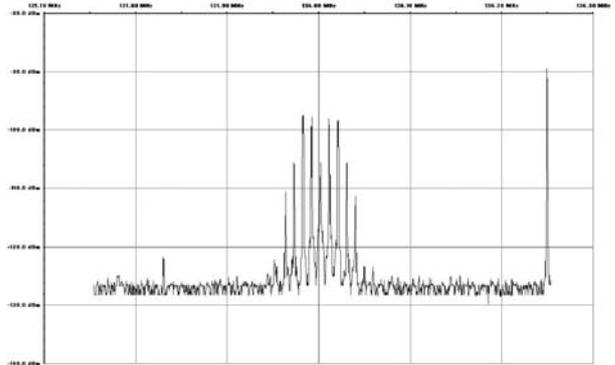
Figure 20 : Interference on ACC/Southwest's frequency sector LG

This last case illustrates the added value of the Be-90/MDF-124 system. During the month of May 2004, ACC/Southwest had been subject to many disturbances on band 135.96MHz. The pilots had described these phenomena as noises like a "machine gun", which seemed to indicate that for once the troublemaker was not an FM radio, but rather a parasite coming from a factory or some kind of electrical equipment. The first operations planned by DO were unfruitful since the phenomenon had disappeared before the aircraft took off. It was only during the third attempt that the signal could be followed as far as the vertical over the Chinon nuclear power plant. This interference, the cause of which has been identified later as a non authorized monitoring system functioning on the 136-137MHz band, would have been difficult to locate without the capabilities of the direction finder. Furthermore, with a longer operation time, the aircraft could not have been airborne during the periods when the ACC/Southwest was disturbed due to the random occurrence of the phenomenon over a period of time.
