Aaron A. Wilson
Associate Program Engineer
Avionics Engineering Center
224 Stocker Center, Ohio University
Athens, Ohio 45701, USA
Email:wilsona@ohio.edu

David A. Quinet
Senior Program Engineer
Avionics Engineering Center
228 Stocker Center, Ohio University
Athens, Ohio 45701, USA
Email: quinet@bobcat.ent.ohiou.edu

Glide Slope Considerations to Provide Support for Aircraft Certification for Steep Angle Approaches.

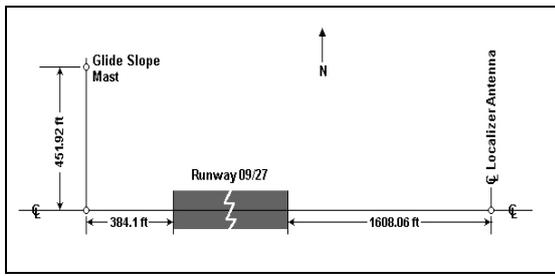
Figure 1 shows the layout of the site used for these tests. Note that the glide slope mast is located in front of the threshold and does not align the landing aircraft with the hard surface of the runway. Since this is a test facility, the mast was located in an area which would not interfere with airport operations.

Figure 1. Test Facility Equipment Locations with Reference to Runway 09L at TMB.

For these tests, the missed approach point is 344 feet AGL or 3500 feet prior to the glide slope antenna mast; the latter distance should provide ample opportunity for the pilot to make adjustments for landing on the runway.

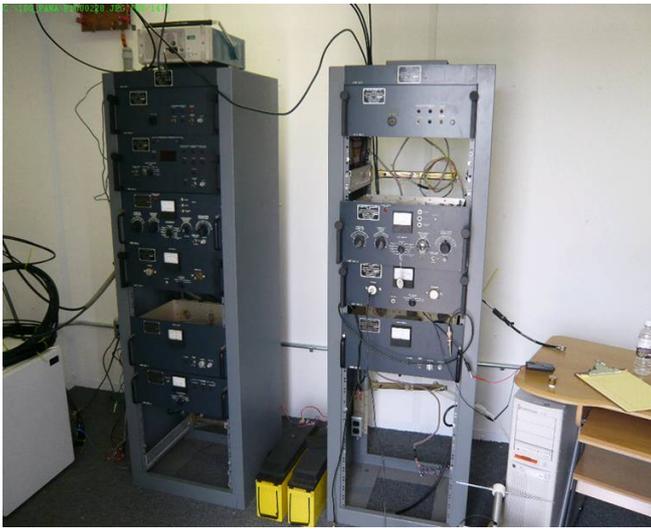
Figure 2. Picture Showing the Glide Slope Transmitting Equipment Used to Generate RF Signals for the Steep Angles. Transmitter on the Right is for 5.5 Degrees and on the Left for 6.65 and 8.65 Degrees.

Initial certification flights only required a path angle of 5.5 degrees where later flights required 6.65 and 8.65 degree angles as well. To facilitate switching between path angles during the engineering and certification flights, two transmitters were used (see Figure 2). For each glide path angle, two antennas are required. Four antennas were mounted on the mast and adjusted to provide the proper angle of 5.5 and 6.65 degrees. Since the glide slope mast was heavily populated, a separate structure was attached to the glide slope mast to accommodate the two antennas that provided the 8.65 degree angle (see Figure 3). This configuration of equipment allowed efficient switching between antenna systems, and thus path angles, which minimized the probability of radiating the wrong angle.

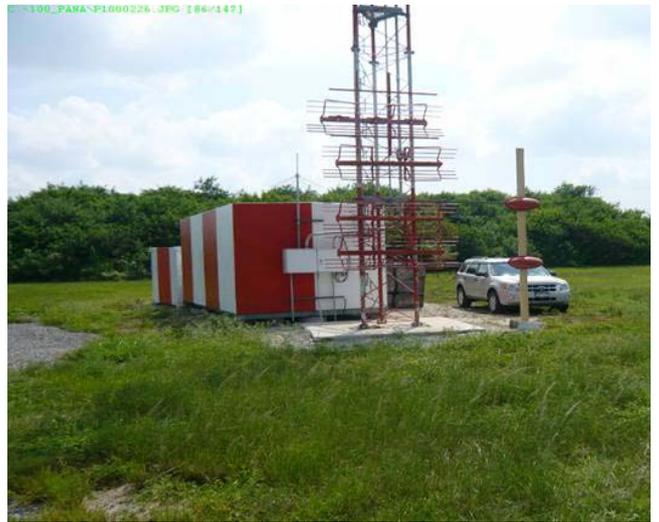
Figure 3. Picture Showing the Glide Slope Antennas Used to Generate the Proper Glide Path Angle.

AEC personnel set the path angles by adjusting the height above ground of the upper antenna on the glide slope mast. Flight measurements were performed to verify that the guidance signal met Category I requirements. Table 3 provides a summary of the glide slope vertical guidance performance. The traces in Figure 4 through Figure 6. show the glide slope vertical guidance performance for the various angles.

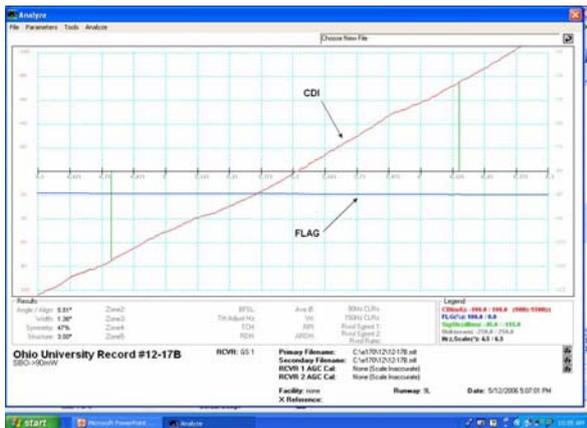
Figure 4. Measured Glide-Slope Guidance Performance (5.5-degrees). [5/12/2006]

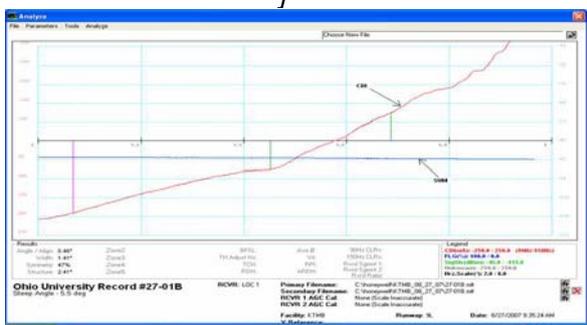
Figure 5. Measured Glide-Slope Guidance Performance (5.5 Degrees). [8/27/07]

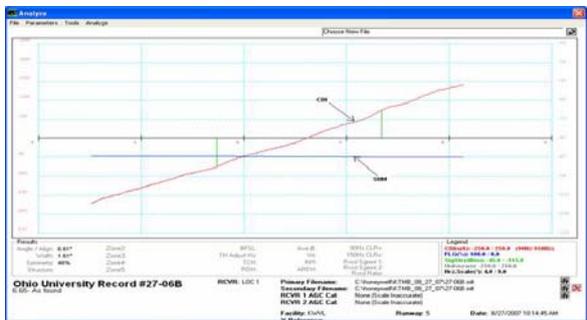
Figure 6. Measured Glide-Slope Guidance Performance (6.65 Degrees). [8/27/07]

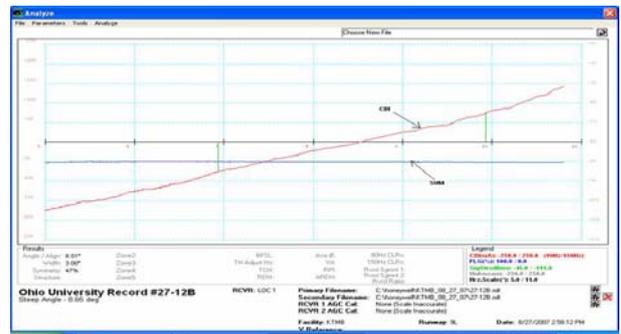
Figure 7. Measured Glide-Slope Guidance Performance (8.65 Degrees). [8/27/07]

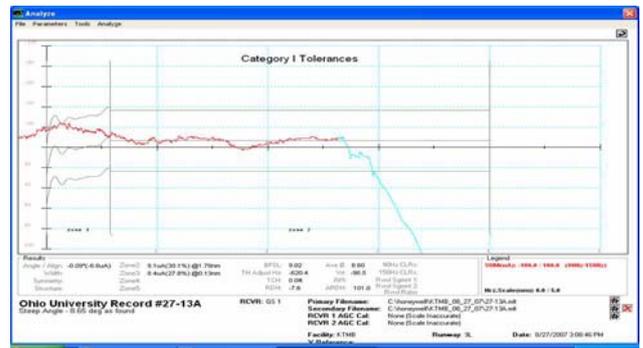
Figure 11. Glide-Slope Path Quality (Category I Tolerances) (Path Angle 8.65 Degrees).[8/27/07]

The glide-path angle from the above measurements was obtained from a sample of one point; the average angle throughout the entire approach can then be verified based on the path roughness. An approach was then flown and the glide-slope guidance quality evaluated against Category I and Category III tolerance limits. A summary of the glide slope performance along an approach is provided in Table 4 and shown in Figures 8 through 11 and Figures 12 through 15 against Category I and Category III tolerances, respectively.

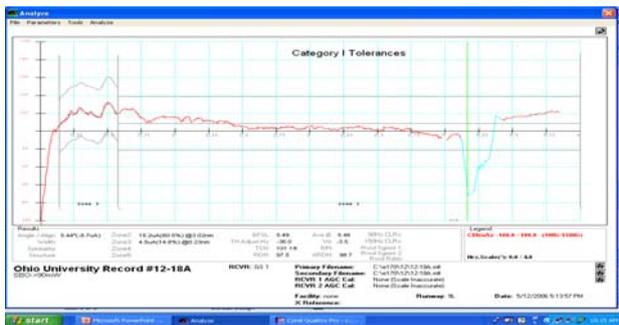
Figure 8. Glide-Slope Path Quality (Category I Tolerances) (Path Angle 5.5 Degrees).[5/12/06]

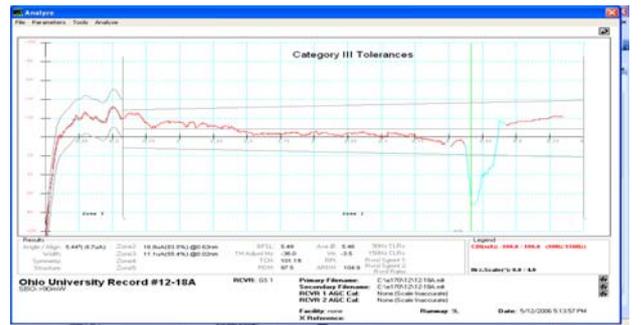
Figure 12. Glide-Slope Path Quality (Category III Tolerances) (Path Angle 5.5 Degrees)[5/12/06]

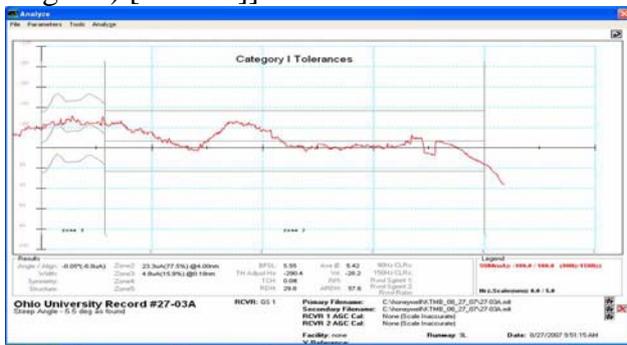
Figure 9. Glide-Slope Path Quality (Category I Tolerances) (Path Angle 5.5 Degrees).[8/27/07]

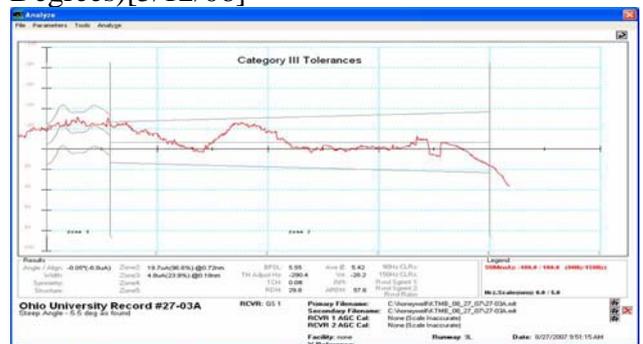
Figure 13. . Glide-Slope Path Quality (Category III Tolerances) (Path Angle 5.5 Degrees).[8/27/07]

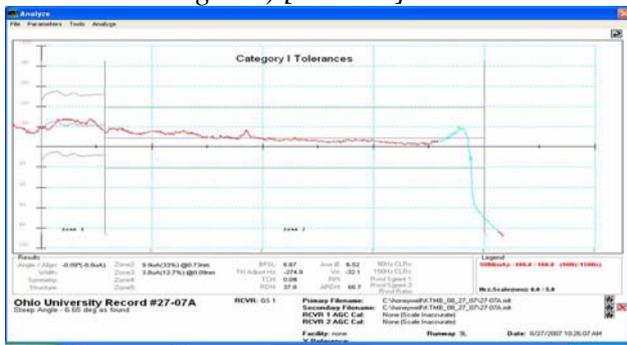
Figure 10. Glide-Slope Path Quality (Category I Tolerances) (Path Angle 6.65 Degrees).[8/27/07]

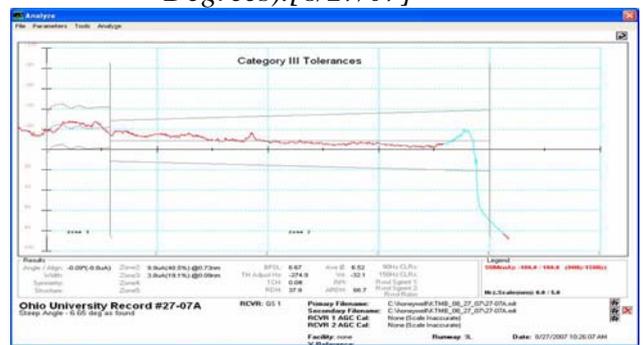
Figure 14. Glide-Slope Path Quality (Category III Tolerances) (Path Angle 6.65 Degrees).[8/27/07]

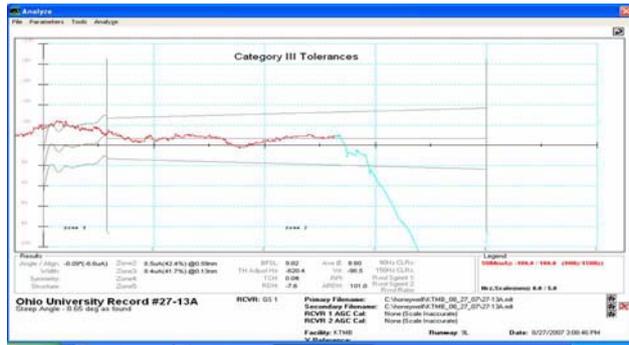
Figure 15. Glide-Slope Path Quality (Category III Tolerances) (Path Angle 8.65 Degrees).[8/2/07]

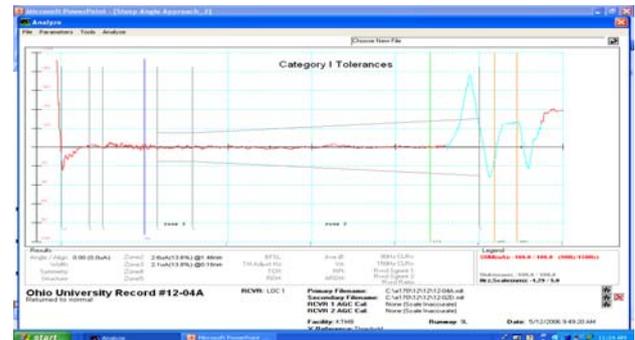
Figure 17. Localizer Guidance Quality (Category I Tolerances) [5/12/06].

An approach was then flown and the localizer guidance quality was evaluated against Category I and Category III tolerance limits. A summary of the localizer performance along with an approach is provided in Table 6 and shown in Figures 17 and 18 against Category I and III tolerances, respectively.

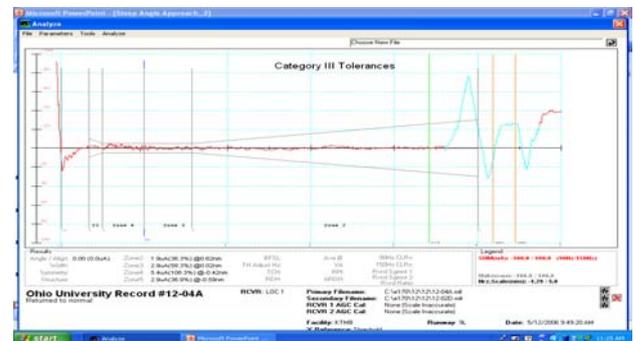
Figure 18. Localizer Guidance Quality (Category III Tolerances).[5/12/06]

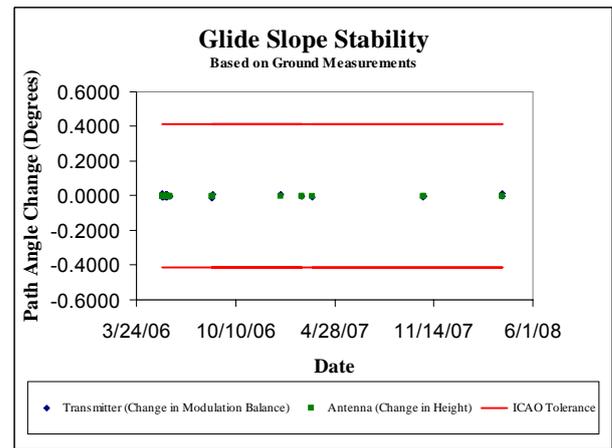
Figure 19. Confirmation That Path Angle Remained Within Tolerance During Tests - TX Modulation and Antenna Height.

A change in the upper antenna height above the ground of 1 inch equates to a 0.01-degree path angle change. The height of each antenna was measured prior to and after each flight test using a tape measure. In addition, the path angle can also be changed with a change in the transmitter modulation balance. For a 5.5 degree path angle, a 0.001 DDM change equates to a 0.0075-degree path angle change. The modulation balance was also verified prior to and after each flight test. These ground measurements confirmed (see Figure 19) that the path angle was maintained within ICAO limits during the entire testing period.

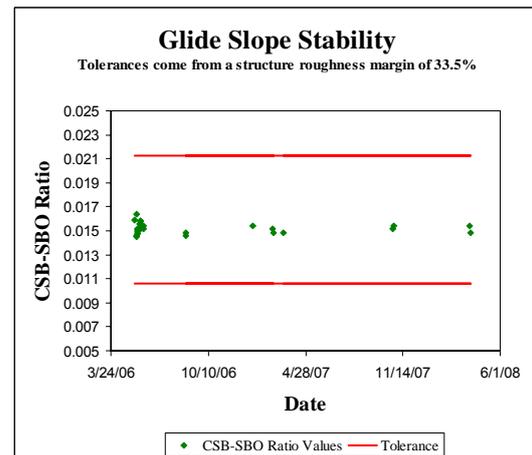
Figure 2011. Confirmation That Path Angle Remained Within Tolerance During Tests - TX Parameters.

The glide slope structure roughness can be affected if the terrain in front of the mast is changed. A visual inspection confirmed no earth movement occurred in the path forming area during the testing period. In addition, the CSB-SBO power ratio change can alter the path structure roughness. Power measurements using BIRD wattmeter elements were taken prior to and after each flight test. These measurements (see Figure 20), along with the visual inspection of the terrain, confirm that the course structure roughness did not increase beyond ICAO Category I tolerances.
