Critical and Sensitive Areas of ILS and their 3rd Dimension - Examples, Effects and Proposals

Gerhard Greving, *NAVCOM Consult, Ludwigsburgerstr. 23, 71711 Steinheim/Germany*
L. Nelson Spohnheimer, *Spohnheimer Consulting, 35216 Military Rd S, Auburn, WA 98001*

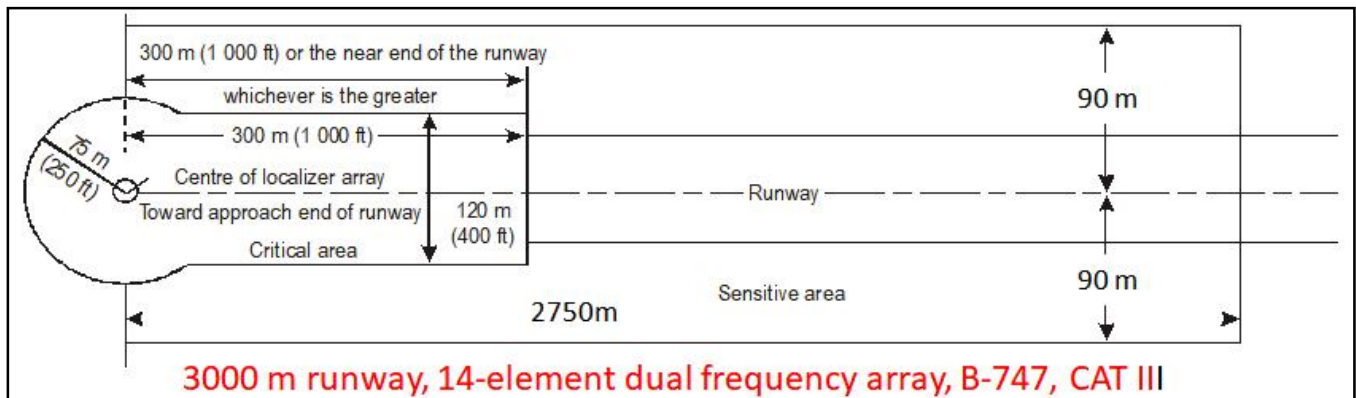
Figure 1. Sample LOC CASA Sizes

Some states use ICAO-provided fixed CASA dimensions based on common aircraft sizes and the category of operation, while others define CASA areas uniquely according to airport geometry, antenna system type, and specific aircraft sizes. Samples provided in Annex 10's Figures C3A and C4B are excerpted in Figures 1 and 2.

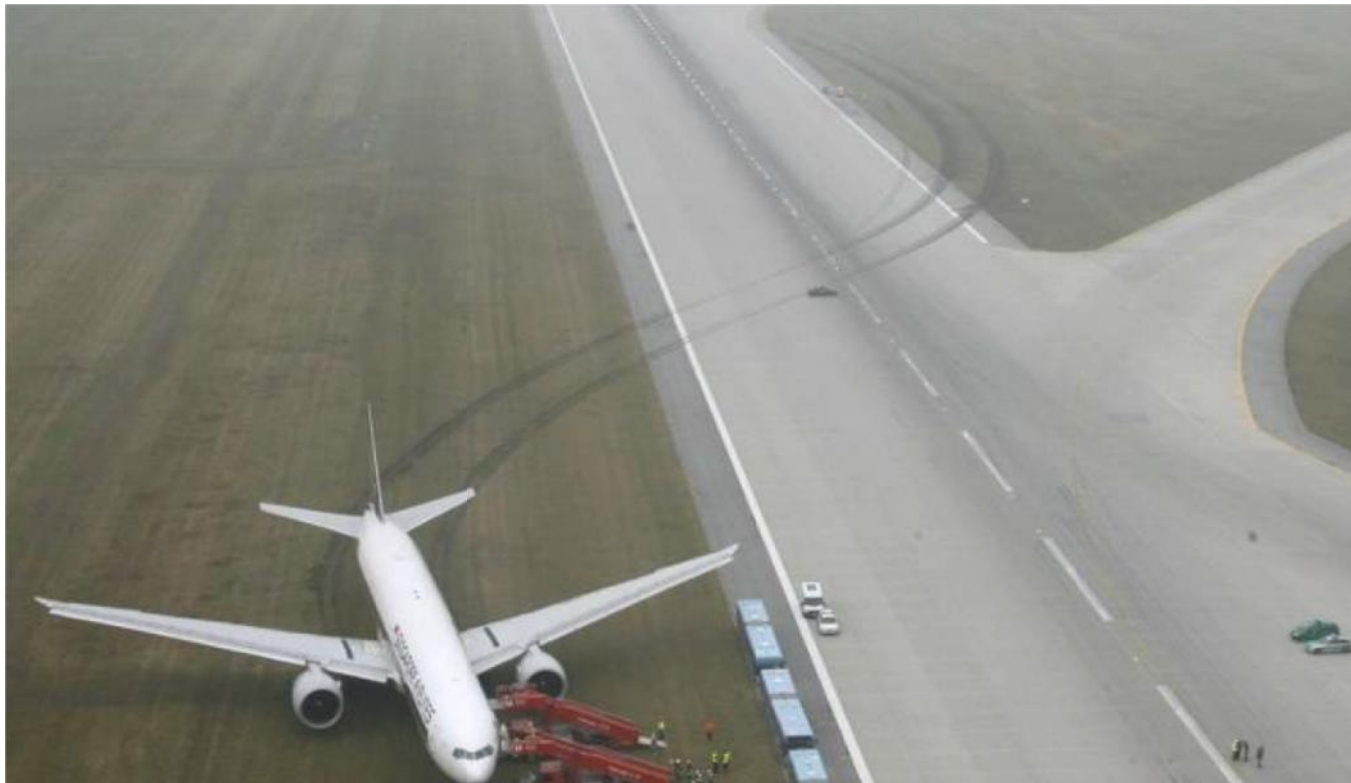
Figure 4. B-777 ILS Autoland Event

In 2011, a B-777 departed the runway at an international airport after touchdown on a CAT I ILS autoland approach (Figure 4). Despite the obvious problem, very fortunately no one was seriously injured, and the aircraft was undamaged.

At approximately 30 feet AGL, the 777 began to roll left, and the left main gear touched down about 490 meters inside the threshold. The autopilot switched to roll out mode, and the aircraft rolled towards the left edge of the runway, crossing it at about 1100 meters down the runway. Rudder inputs disengaged the autopilot. The 777 crossed the runway to the right and exited the right edge approximately 1620 meters down the runway. The aircraft came to a stop south of the runway on grass about 60 meters off the runway and 1780 meters inside the runway threshold.

The subsequent investigation found flight data recorder data indicating the three ILS receivers recorded localizer signal deviations in both directions before the autopilot changed into roll out mode. A few seconds prior to the roll out mode change, the deviation increased to the right of the extended center line, causing the initial roll to the left to minimize the localizer deviation. Quantitative numerical simulation results can be found in the 2012 IFIS paper [4] of the authors.

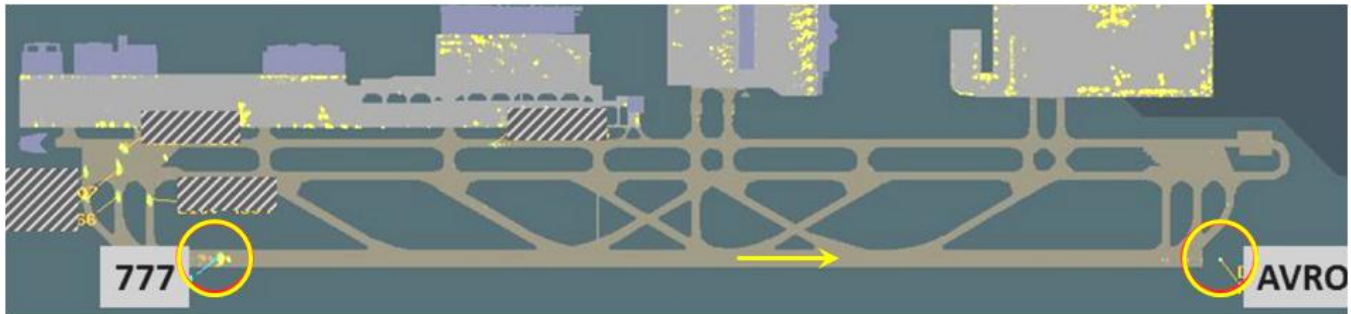
Figure 5. Relative Positions of Landing (left) and Departing (right) Aircraft

The runway was operating in mixed mode (landings and takeoffs from the same runway.) When the 777 was about 2.1 NM prior to touchdown, a BAe Avro began its takeoff run. When the landing 777 crossed the runway threshold, the Avro was

climbing out and still short of the runway end (Figure 5). Due to an unusually large LLZ antenna system setback, the Avro overflew the localizer antenna at a height of 740 feet 26 seconds after the 777 crossed the threshold.

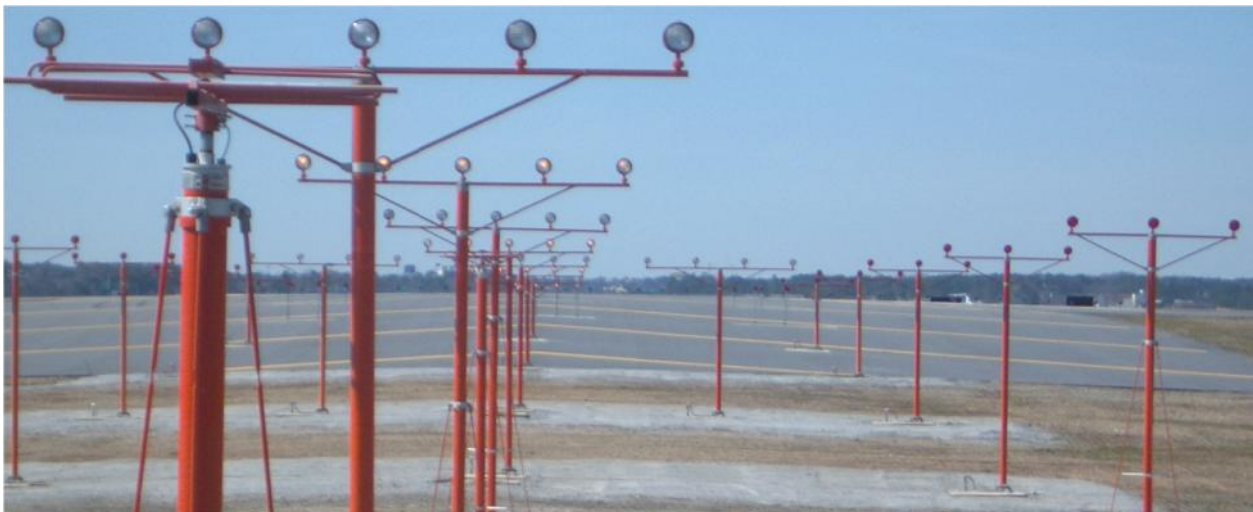
Figure 6. Example of CAT III LLZ with (Symmetrical) Approach Light Stations immediately in front of Antennas

Starting aircraft have the potential to distort the ILS-signal for the next landing aircraft during mixed mode operation. In the ideal case, the starting aircraft climbs while remaining directly above the runway centerline, and no DDM-distortions occur for the landing aircraft due to the symmetry of the geometry. Even in an extreme case of approach lights immediately in front of an LLZ (Figure 6), the horizontal light bars and embedded wiring do not cause LLZ performance problems if they are located symmetrically around the extended centerline.

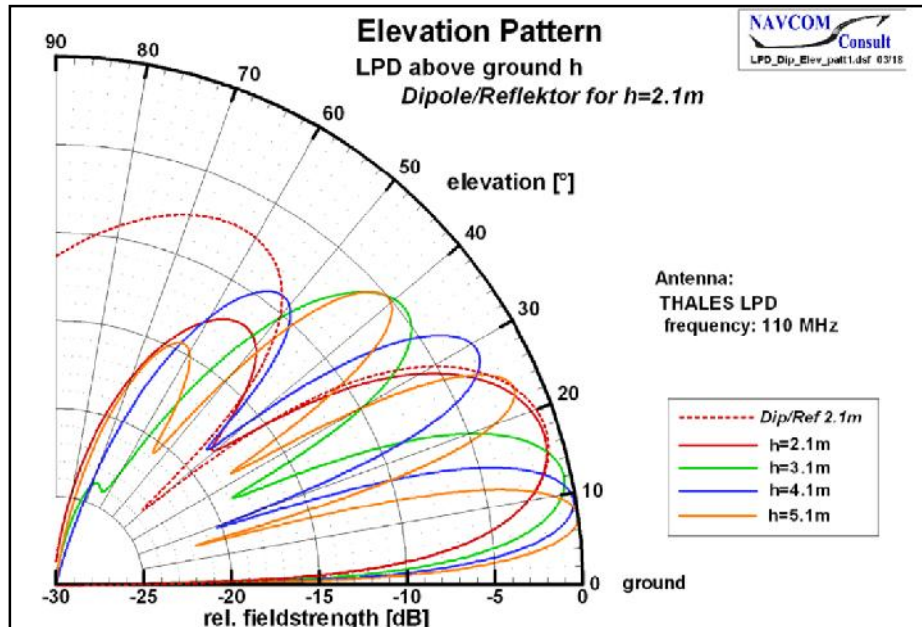
Figure 7. Elevation Pattern of LLZ Antennas: Dipole with Reflector (2.1 m) and LPD at Various Heights above Ground

However, if the starting aircraft deviates from the ideal climbing path/slope, asymmetric scattering components generate large distortions until shortly after the localizer is crossed. The problem is aggravated by the relative heights of the two aircraft, due to the typical vertical antenna pattern of an LLZ (Figure 7), which is horizontally polarized. The arriving aircraft is at a low elevation angle and low signal level, while the departing aircraft is at a much higher elevation angle and likely to be illuminated by much higher signal levels.

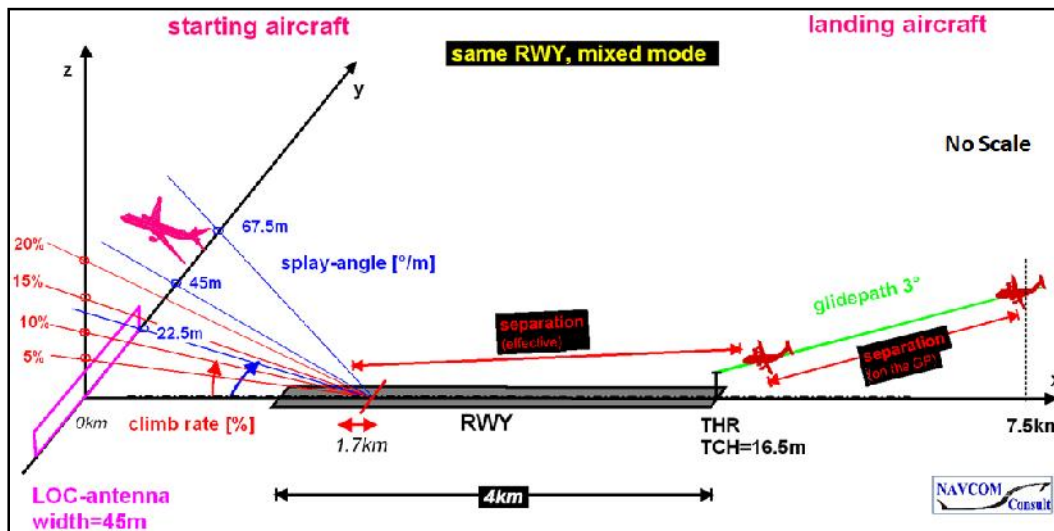
Figure 8. Modeling Scenario for LLZ Effects Resulting from Mixed-Mode Runway Use

To gain an awareness for the magnitude of the total system problem, a high-fidelity modeling scenario (IHSS, by NAVCOM, using Method of Moments and Improved Physical Optics) considers several parameters, including the effective separation between the arriving and starting aircraft, the splay or drift rate of the starting aircraft away from extended centerline, the starting aircraft type and climb rate, and the LLZ antenna setback, height, and type (Figure 8).

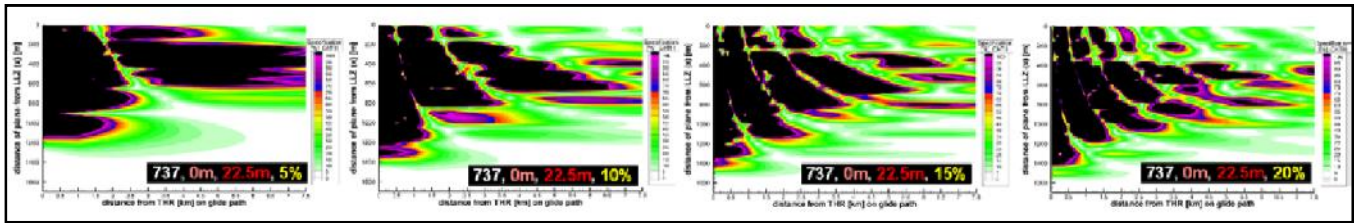
Figure 9. LLZ Errors from Departing Aircraft with 5% (left) to 20% (right) Climb Rates for 2.1 m LLZ Antenna Height

Figure 9 presents error results for departing aircraft climb rates of 5, 10, 15, and 20% (left to right), with the aircraft overhead the LLZ antenna at 22.5 m laterally from extended centerline. The antennas are mounted a nominal 2.1 m above ground. For most cases with the departing aircraft being up to 1000 m inside the LLZ, the errors are generally over 100% of CAT III tolerance throughout most of the approach.

The following figures present LLZ errors as a percentage of CAT III tolerances, for varying conditions. All scenarios assume a B-737-800 or a B-777-300 for the starting aircraft at 2700 m from the LLZ on a 4000 m runway. The vertical axis of each

graphic is the distance of the departing plane from the LLZ (0m at top, 1700 m at bottom), and the horizontal axis is the distance of the landing aircraft prior to the approach threshold while on the 3.00° glide path (0 km at left, 7.5 km at right). The LLZ antenna system is a 21/7-element array located 700 m beyond the runway stop end. Error amplitudes are presented by color, with the lightest colors being very small errors and darker colors being very large errors - black represents 100% of tolerance or more. The results assume a perfect LLZ beam except for the effects of the departing aircraft - actual installations will of course have other errors on the LLZ from static or moving objects on the airfield.

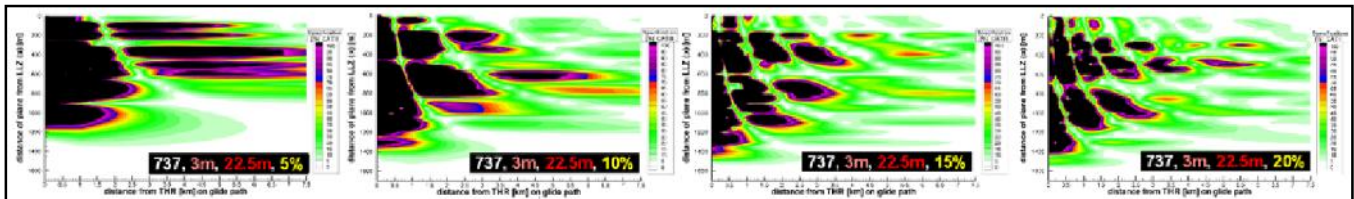
Figure 10. LLZ Errors from Departing Aircraft with 5% (left) to 20% (right) Climb Rates for 5.1 m LLZ Antenna Height

Figure 10 maintains the same conditions as for Figure 8, except that the LLZ antennas are elevated by an additional 3 m, to a height of 5.1 m. Elevating the antennas by an approximate 150% will improve the signal strength at low elevation angles for the landing aircraft, while decreasing the reflected signal levels somewhat from the departing aircraft at some parts in the higher volume. However, while the size of each "elliptical" black area is noticeably smaller, the improvements are not dramatic, and many conditions with more than 100% of CAT III errors remain. (Elevating the antennas also has potential challenges, such as maintaining mechanical stability under wind and ice loading, and increasing static error levels for some runway geometries from structures/objects low in elevation angle, such as distant hangars or taxiing/stopped aircraft.)

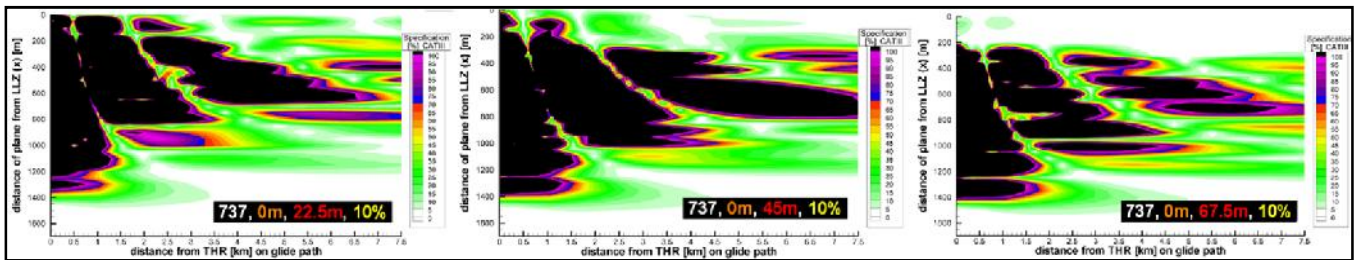
Figure 11. LLZ Errors from Departing Aircraft, Lateral Offsets over LLZ of 22.5 (left) to 67.5 m, 2.1 m LLZ Antenna Height

Figure 11 maintains the same conditions as for Figure 8, except that the departing aircraft's climb rate is fixed at 10%, while its splay angle (lateral drift rate) is varied such that when overhead the LLZ antennas, the aircraft offset is 22.5 m (left), 45 m (center), and 67.5 m (right) from extended runway centerline. The 22.5 m offset at left thus has the aircraft directly over one edge of the antenna system. The areas in the graphic with errors $\geq 100\%$ are somewhat larger in general than for Figure 9 conditions.

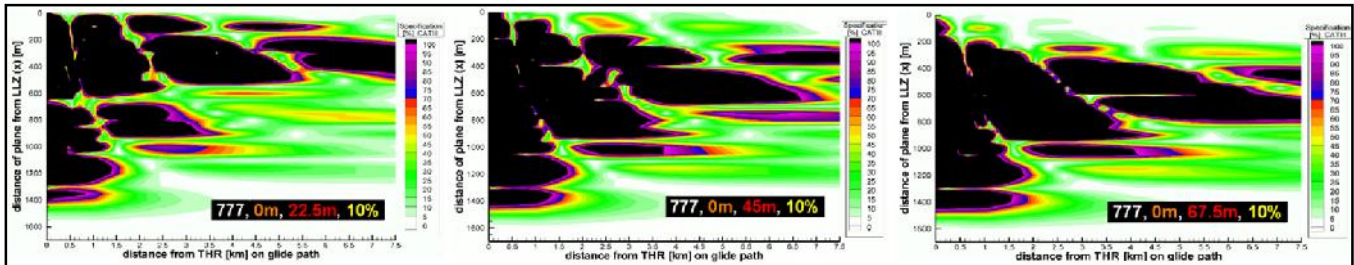
Figure 12. LLZ Errors from Departing Aircraft, Lateral Offsets over LLZ of 22.5 (left) to 67.5 m, 2.1 m LLZ Antenna Height

Finally for the mixed mode scenario, Figure 12 maintains the same conditions as Figure 11, except that the departing aircraft is changed to a larger model, a 777-300, with a 10% climb rate and lateral offsets when overhead the LLZ antenna of 22.5 m, 45 m, and 67.5 m. Not surprisingly, the graphical areas with $\geq 100\%$ errors are larger.

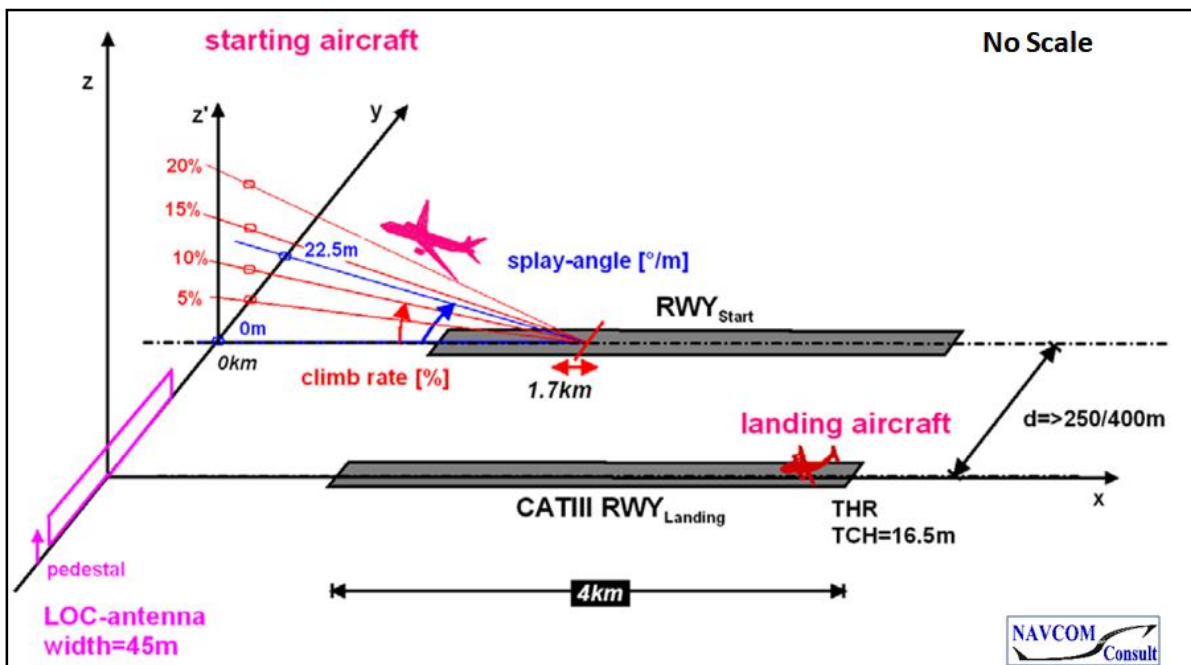
Figure 13. Two-Runway Scenario, Simultaneous Takeoffs and Landings

Another common actual airport scenario related to CASA is simultaneous takeoffs and landings from TWO runways which are typically somewhat closely spaced, e.g., 250 and 400 m, as shown in Figure 13. In the following examples, the departing aircraft is again a B-737-800 starting its takeoff roll on a parallel runway at 2700 m from the landing aircraft's LLZ. The splay angle/lateral offset of the departing aircraft from its extended runway centerline is zero degrees/meters - ie, there is no lateral drift during the departure. The runway separations, departing aircraft climb rate, and antenna mounting height for the landing aircraft's LLZ will be varied. The resulting guidance errors are calculated for the landing aircraft's receiving antenna at a height of 4 m.

For each two-runway scenario, the predicted error levels from the departing aircraft in the following graphics are presented as a percentage of CAT III tolerances. Error amplitudes are presented by color, with the lightest colors being very small errors and darker colors being very large errors - black represents 100% of tolerance or more. The vertical axis presents the distance in meters (2700 to 1000) of the departing aircraft to a point abeam the LLZ antennas - a distance of 1000 m represents the stop end of the departure runway. A second vertical axis if present shows the time in seconds (~ 0 to 24) from the start of the departing aircraft. The horizontal axis is the distance of the landing aircraft from its LLZ antenna (~ 0.5

km left to 4.5 km right). The results assume a perfect LLZ beam except for the effects of the departing aircraft - actual installations will of course have other errors on the LLZ from static or moving objects on the airfield.

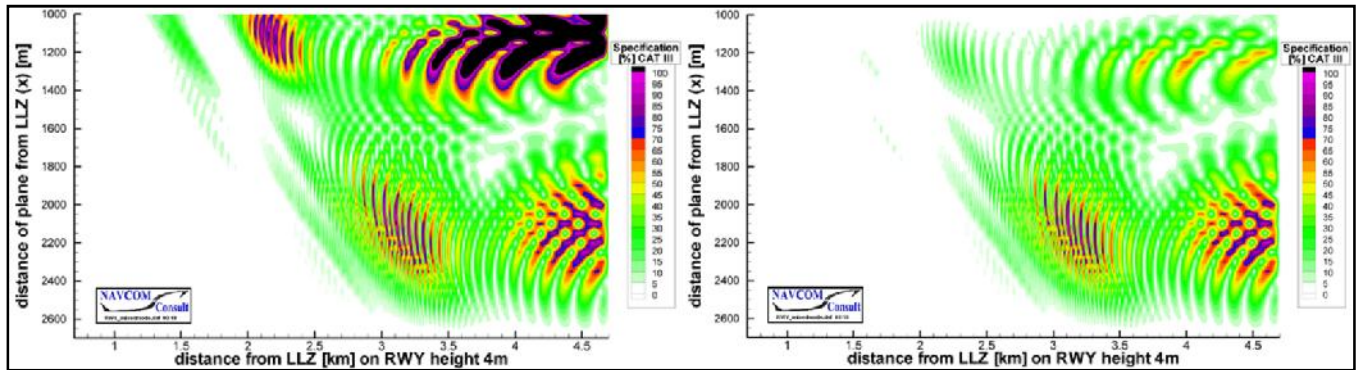
Figure 14. Errors for 250 m Runway Separation, 15% Climb Rate, LLZ Antenna Height of 2.1 m (left) and 5.1 m (right)

Figure 14 presents the predicted landing aircraft guidance errors for the scenario of a 15% climb rate for the departing aircraft, 250 m runway separation, and either a typical 2.1 m mounting height (left) or 5.1 m height (right) for the LLZ antennas. For the 2.1 m LLZ antenna height case, the errors exceed 100% of CAT III tolerances for the departing aircraft within approximately 400m of the departure end of its runway, and the landing aircraft is within approximately 0.5 km of its approach threshold.

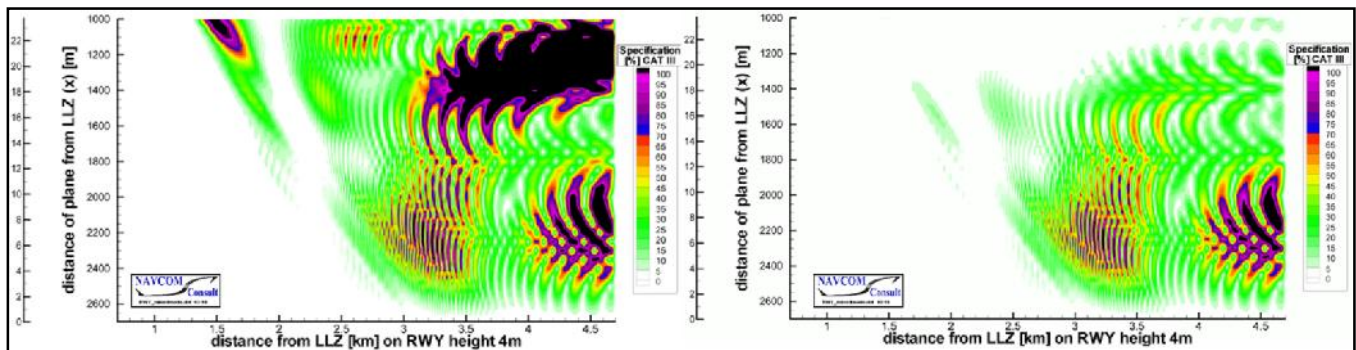
Figure 15. Errors for 250 m Runway Separation, 20% Climb Rate, LLZ Antenna Height of 2.1 m (left) and 5.1 m (right)

Figure 15 presents the errors for the same conditions as in Figure 13, except that the departing aircraft's climb rate is changed from 15% to 20%. Error magnitudes in general are similar, but their specific locations change due to the changed geometry from the faster-climbing departure aircraft.

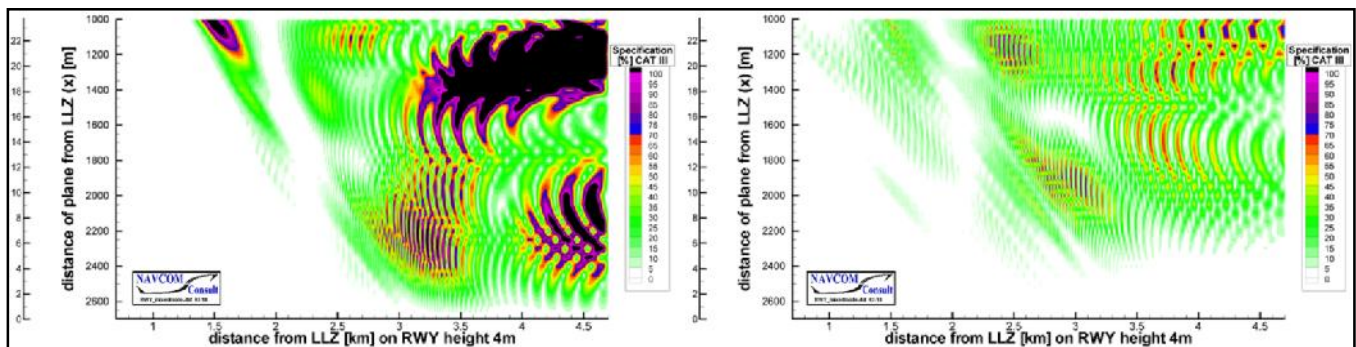
Figure 16. Errors for 250 m (left) and 400m (right) Runway Separation, 20% Climb Rate, LLZ Antenna Height of 2.1 m

Figures 16 presents the errors for a climb rate of 20% and a typical 2.1 m mounting height of the LLZ antennas, for both 250 m (left) and 400 m (right) runway separation. Intuitively, the errors are reduced for the larger runway separation case.

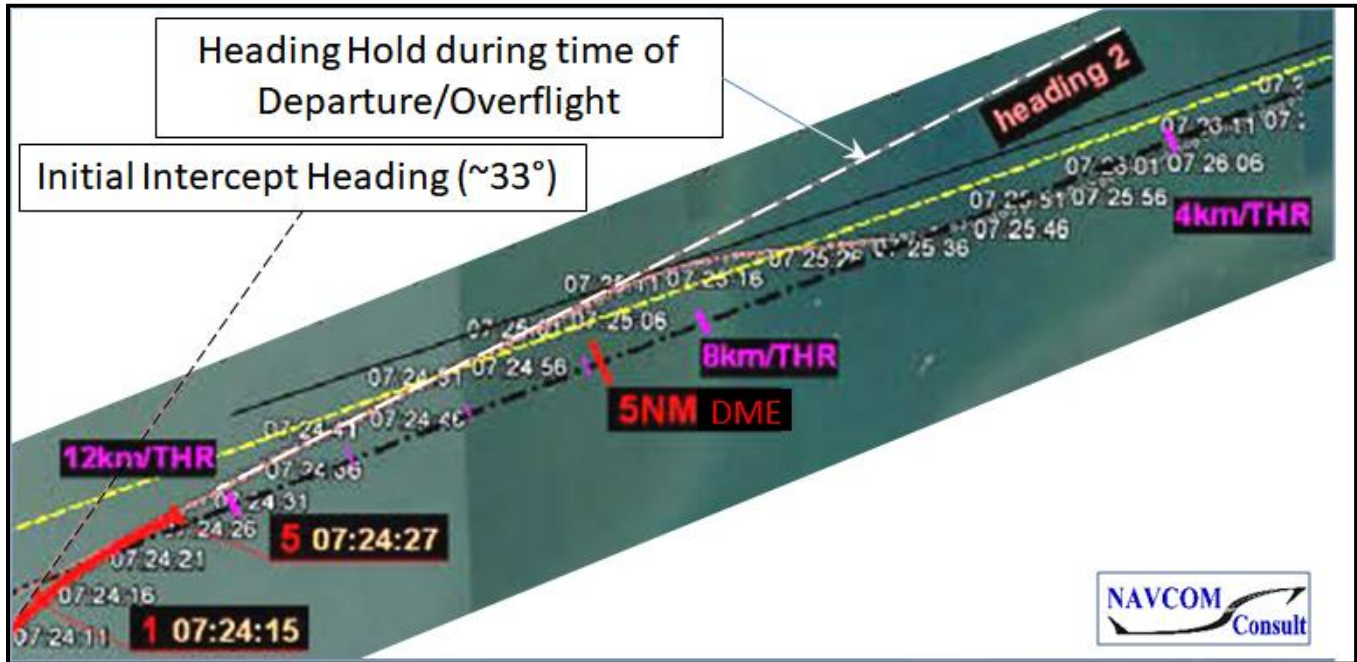
Figure 17. Flight Path of Approaching Aircraft experiencing Heading Hold due to Departing Aircraft Overflight Effects

Another example of a CASA 3rd dimension issue recently occurred at a large international airport. An arriving aircraft was executing an arc toward centerline, prior to capturing the LLZ. A departing aircraft in mixed mode runway operation introduced guidance errors similar to those in the preceding two cases, but while the arriving aircraft was still turning toward the LLZ course. The resulting oscillatory guidance signals exceeded an apparent software-based deviation rate limit in some way and caused the autopilot to change incorrectly to a Heading Hold condition. Figure 17 illustrates the nominal flight path with distances to the runway between 12 and 4 km. The dashed white line indicates the Heading Hold angle during the linear portion of the flight, prior to manual intervention by the crew.

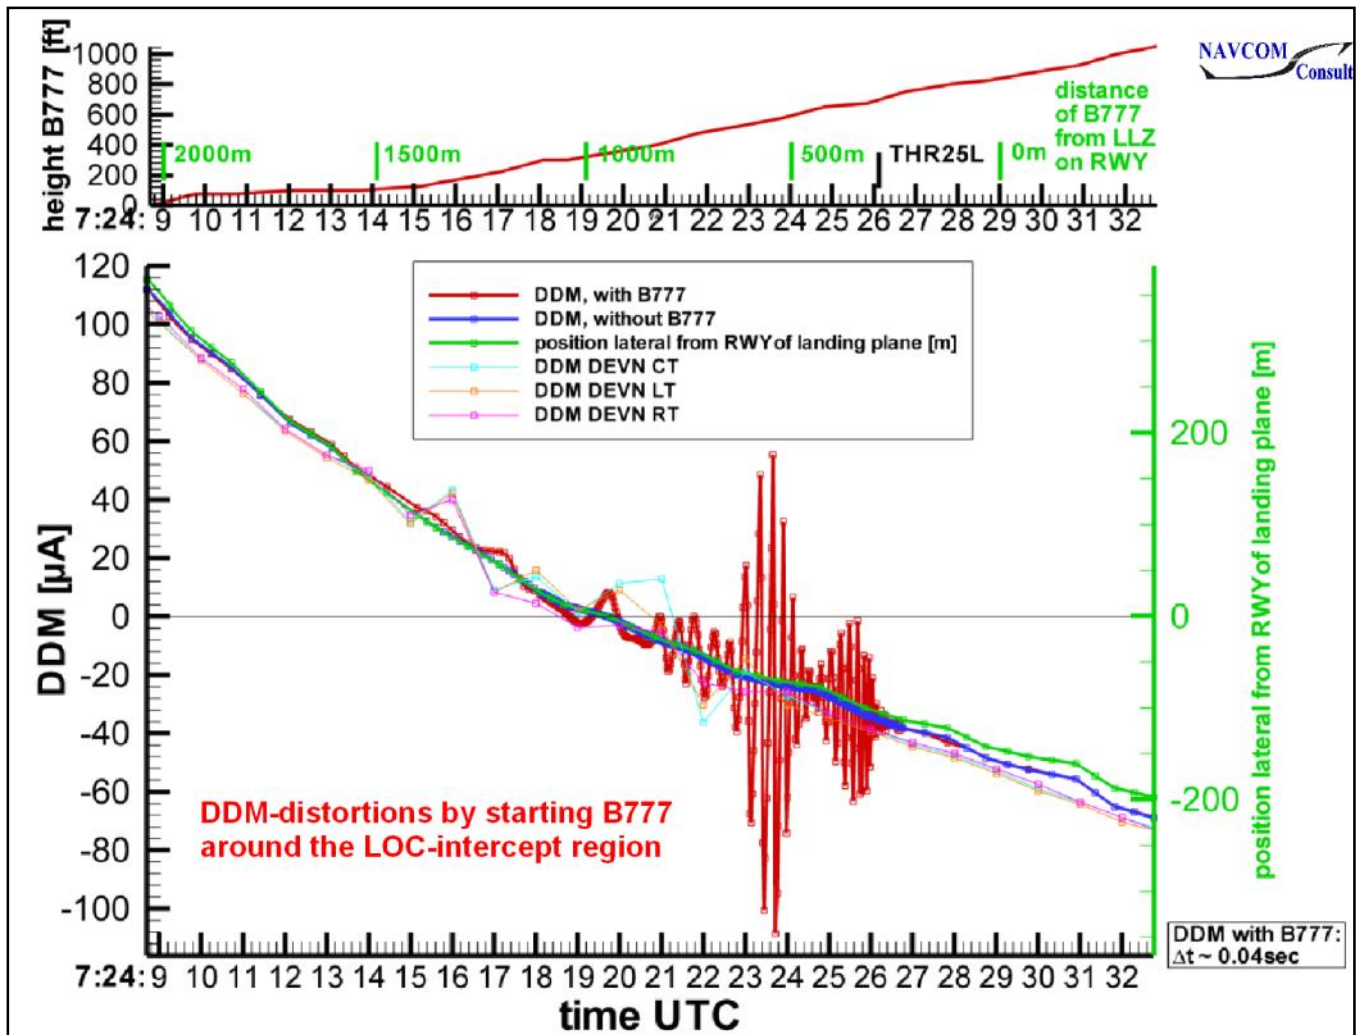
Figure 18. Calculated Double Dynamic DDM Guidance Errors from Overflight to Aircraft Attempting LLZ Capture

Figure 18 illustrates the calculated effects of the overflight on the arriving aircraft, which did not successfully capture the LLZ guidance. For both graphics, the horizontal axis is UTC time in seconds. The upper graphic illustrates the height of the departing (overflight) aircraft in feet on the vertical axis, with its decreasing distance to the LLZ in meters superimposed on the horizontal axis. When this departing aircraft was overhead the LLZ antennas, it was approximately 800' above the runway. The lower graphic illustrates the resulting guidance errors in units of microamperes (μA) of Difference in Depth of Modulation (DDM) or deviation (left vertical axis) to the arriving aircraft, which was initially in a capture mode, then subsequently in a heading-hold mode. The right vertical axis presents the arriving aircraft's lateral position in meters from runway centerline extended. For approximately the first half of the time shown, the change in DDM is a curve as the aircraft turns toward the LLZ course line. At the onset of the errors from the preceding aircraft's overflight, the lateral position of the aircraft becomes linear with time as it transitions through the linear portion of the LLZ guidance in a heading hold mode. Note that throughout this time, the arriving aircraft is in the main beam of the LLZ (i.e., within $\pm 100 \mu A$).

This behavior of a temporary heading hold while briefly encountering deviation errors due to a departing aircraft's overflight of the LLZ may be somewhat sensible only if an aircraft is fully captured on the LLZ and already flying inbound on extended centerline at the onset of the oscillatory errors. These conditions are encountered frequently at most airports. In this case, however, the heading hold condition was initiated shortly prior to the aircraft capturing the LLZ course and remained until the aircraft broke out of the overcast. Fortunately, the crew was able to visually discern in this case that the aircraft was already well left of the runway centerline. The crew manually turned the aircraft toward extended centerline for a missed approach, and a subsequent approach was conducted normally.
