Pre-Flight Check NAV Aids System Using UAV

ABSTRACT

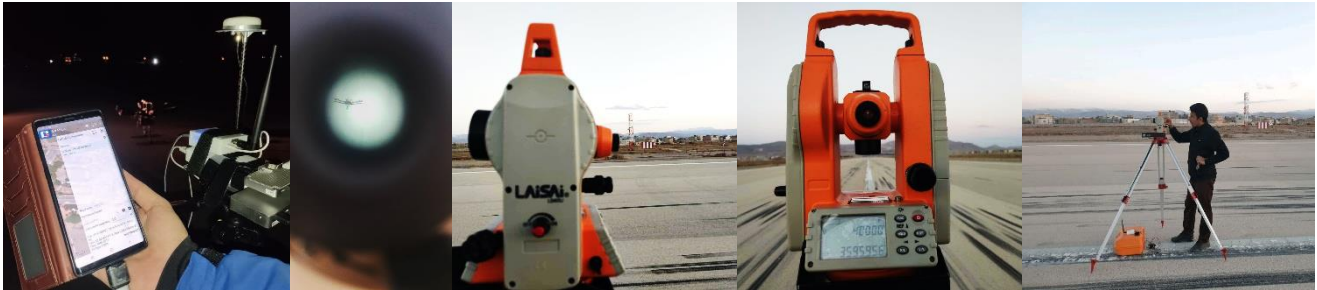
Figure (1) shows the accuracy of the coordinates and measurement references of the method using UAV and RTK and Analyzer were verified using a theodolite camera and the obtained values were equal.

Figure 1. RTK Method Test by Theodolite

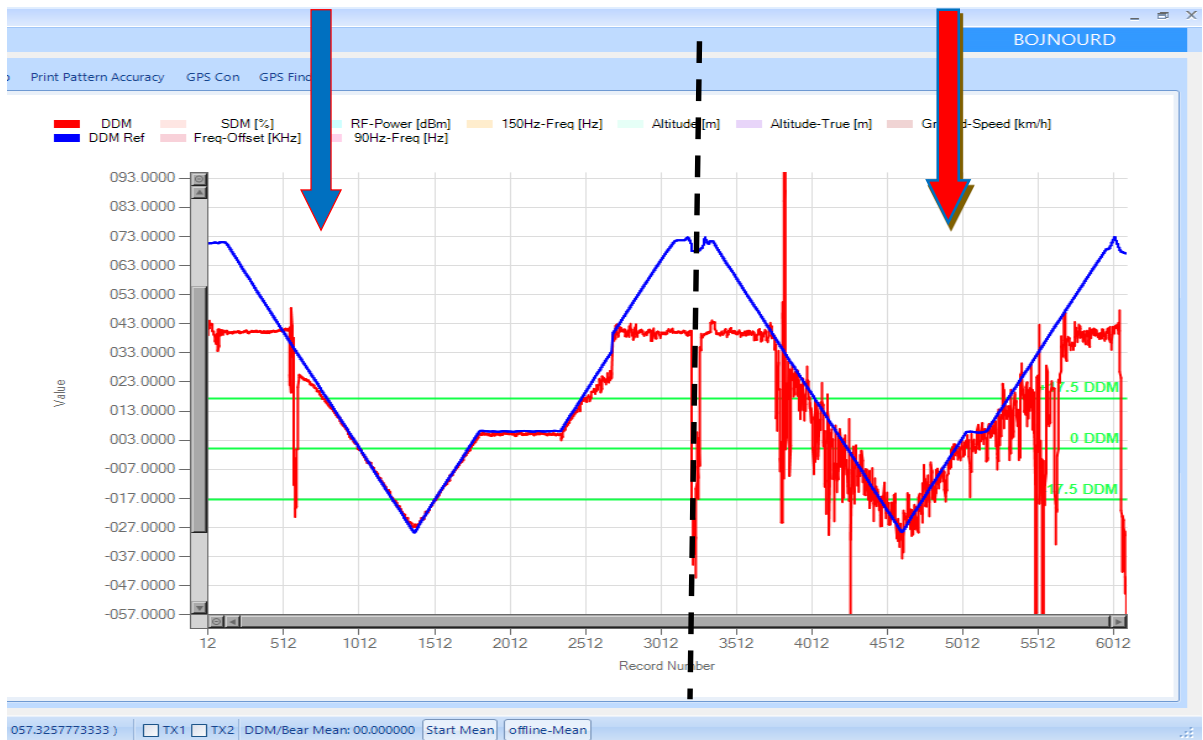
Figure 3. Red Line is RAW DDM - Blue Line is Reference DDM

Pre-inspection UAV: Fly vertically further away from the Inner Marker and stay at RAW DDM = 0.00 for a few minutes to intercept and obtain the GP tilt angle.

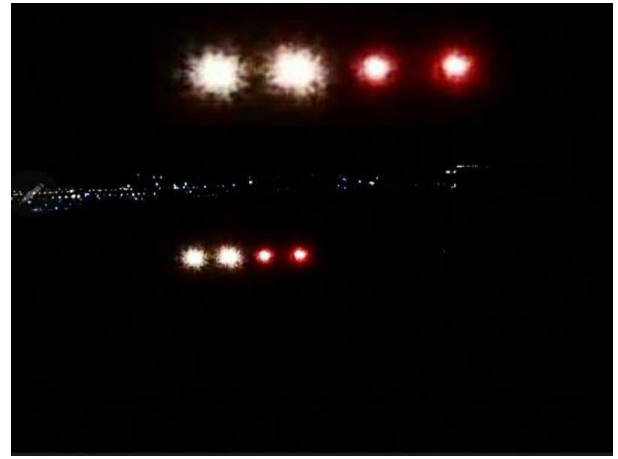
Figure (5) the final image of measuring and adjusting PAPI lights using a UAV.

Figure 5. Calibration by Drone before FLC

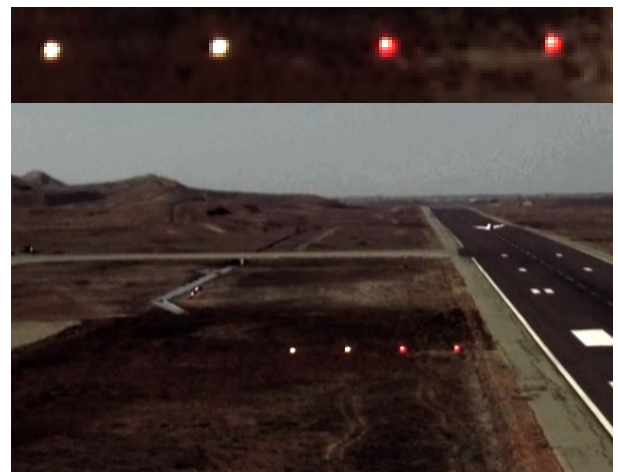
Figure (7) the final image of measuring and adjusting PAPI lights using a UAV.

Figure 7. Calibration by Drone before FLC

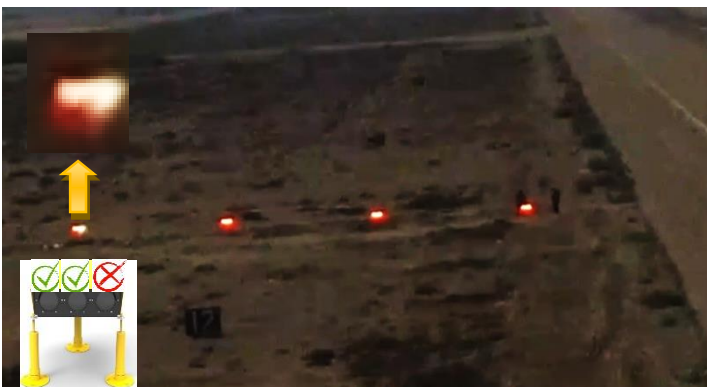
Figure 8. PAPI A Light Error

In checking the papal lights of Chabahar airport, we noticed another problem that the pilot can't see of the inspection plane due to the long-distance during the inspection by the aircraft and also the predominance of white or red light, and that is the inconsistency of the internal lenses of each unit UAVs cause this problem due to the closer and zooming of the image on PAPI lights by the camera installed on the UAV can detect the difference between the lenses of each unit figure 8&9 and possible defects and angular settings of each PAPI light and Take the necessary measures to eliminate them before the flight inspection by the aircraft so that there is no problem in issuing a confirmation of the correct operation of the device.

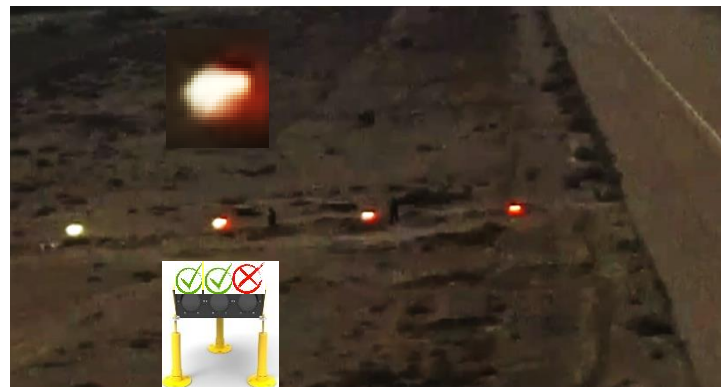
Figure 9. PAPI B Light Error

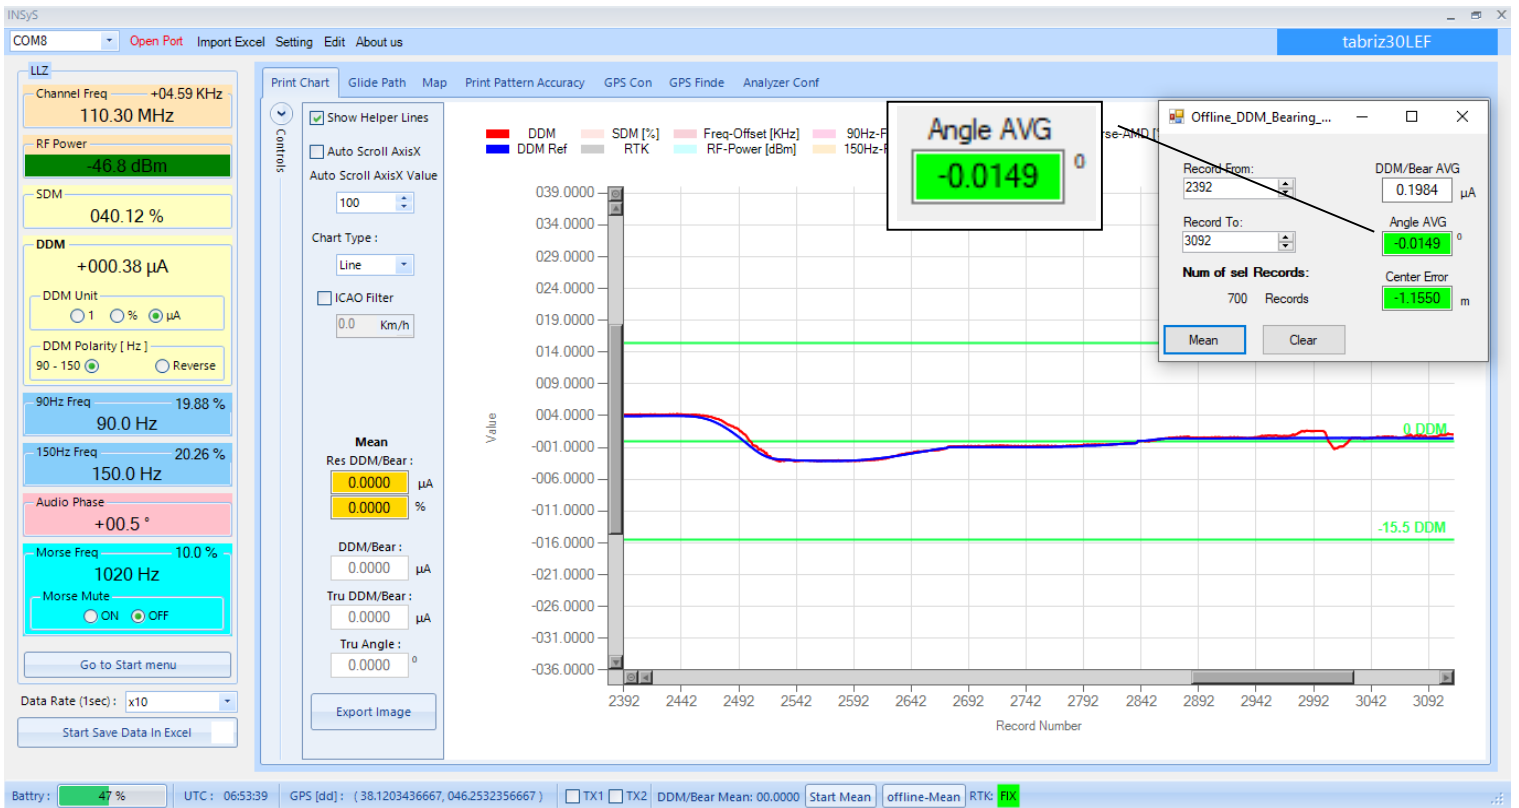
Figure 14. Left Runway Tabriz Airport – LOC Center AVG by Drone / Angle = -0.0149°

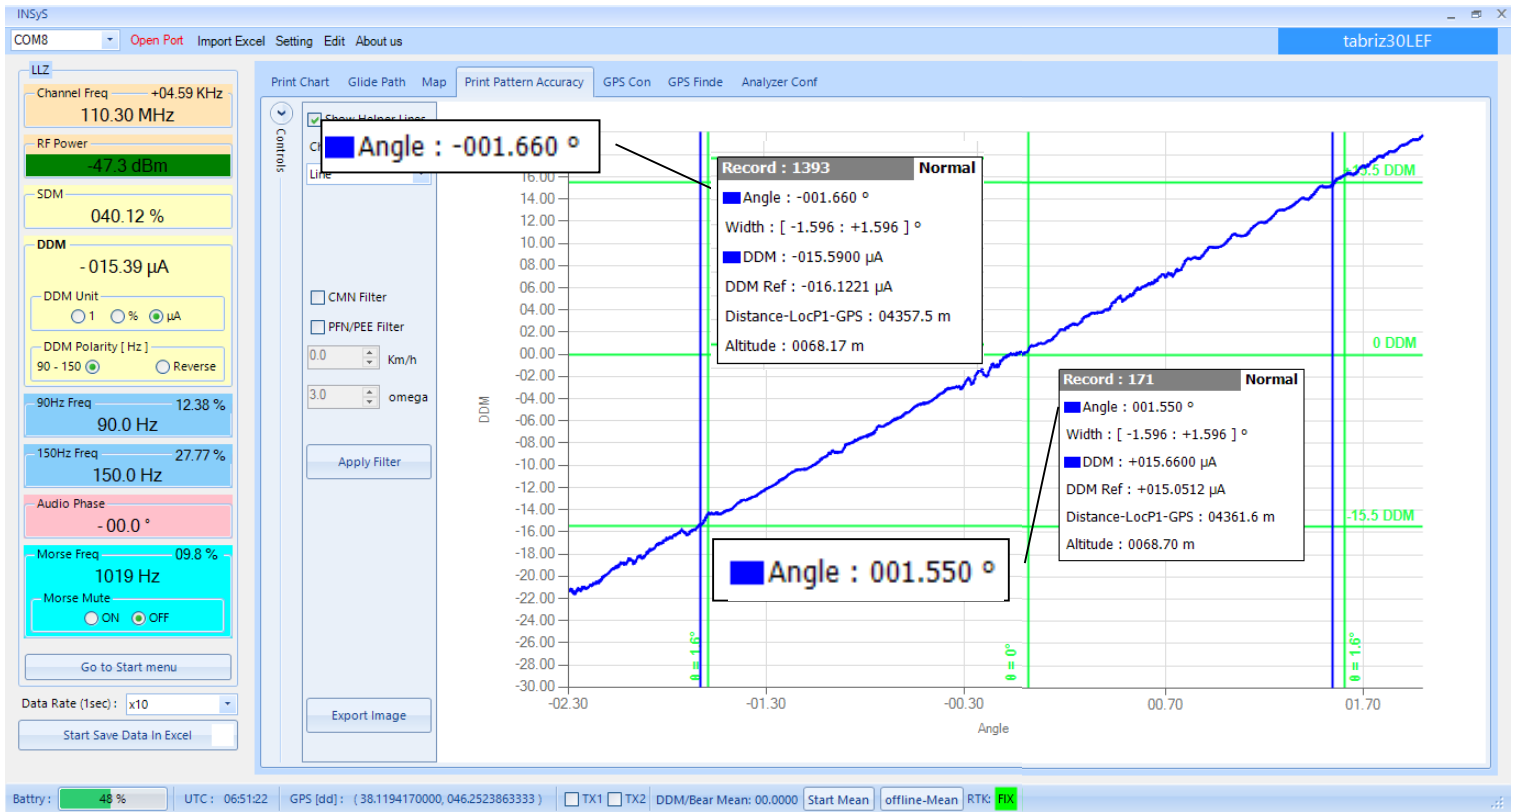
Figure 16. Left Runway Tabriz Airport – LOC Width by Drone / Width = 3.21°

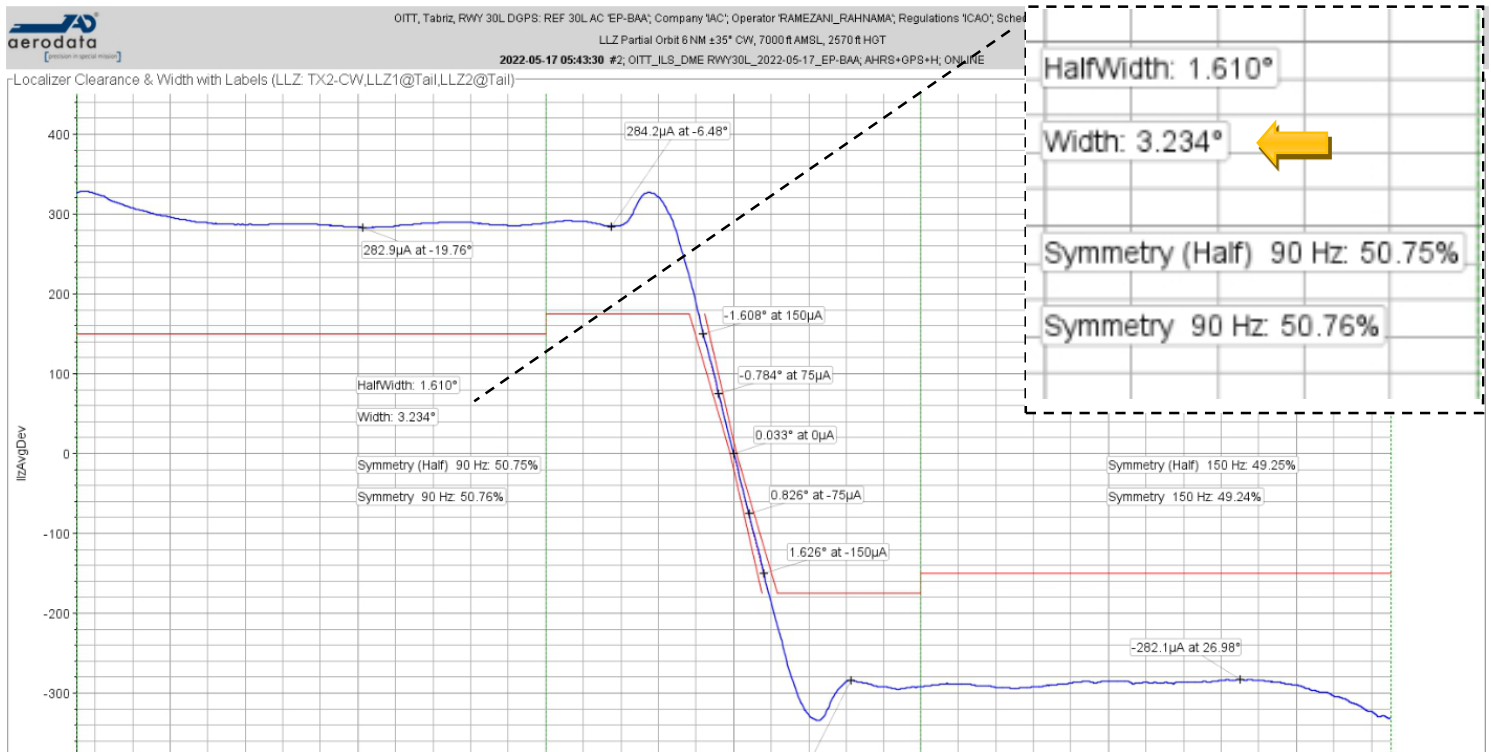
Figure 17. Left Runway Tabriz Airport – LOC Width by Aircraft / Width = 3.23°
