Current Issues in Demanding Flight Measurement Environments

Dr.-Ing. Gerhard GREVING

L. Nelson Spohnheimer

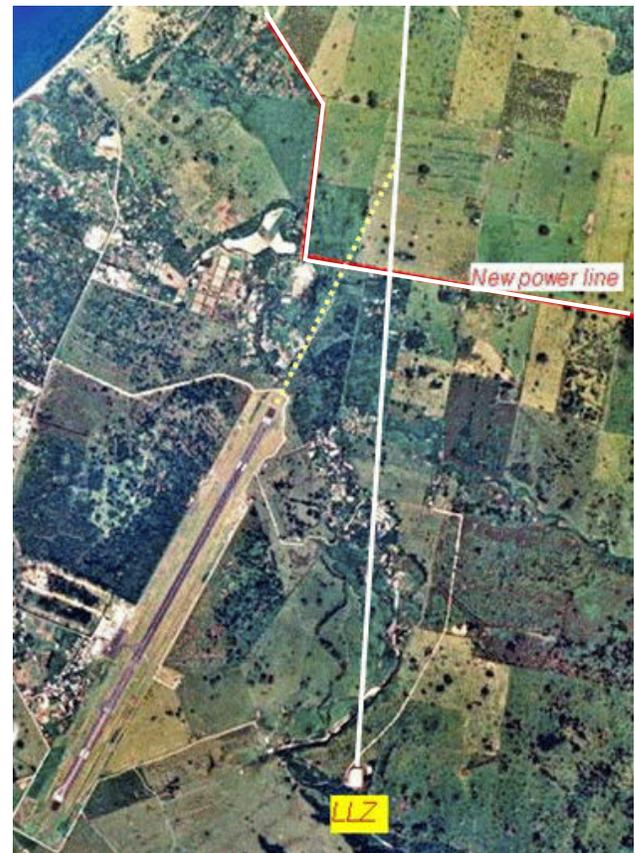
Frequently, an offset approach is desired to a point in space from which a turn to a visual landing can be made. An example is shown in Figure 4, with an airport for which the approach path must be separated from large hills. This necessitates offsetting the localizer (LLZ) by a large angle. The turn point is often considered (arbitrarily), for tolerance application purposes, to be Point B (e.g., middle marker area) on a straight-in approach.

Figure 4. Terrain Avoidance Offset LLZ.

The initially suspected engineering issue was whether a new relatively low power line, shown in Figure 4, was responsible for the out-of-tolerance structure. Figure 5 shows a sample flight measurement of the LLZ structure, with traditional CAT I tolerances shown in heavy dashed lines. The apparent out-of-tolerance segment outside 10 miles is due to positioning and LOC intercept of the

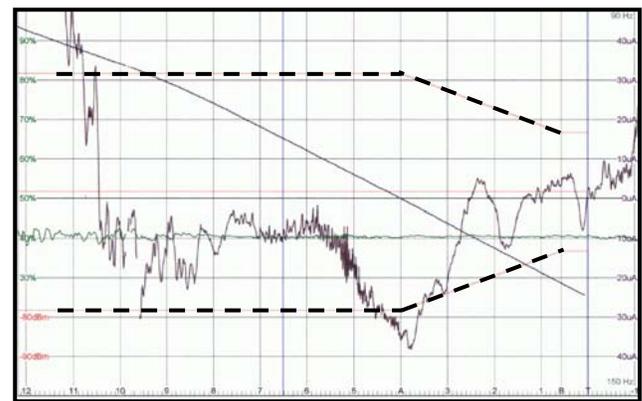
aircraft, and should be ignored. However, the crosspointer near 4 miles exceeds Localizer tolerances.

Figure 5 Out-of-Tolerance Results for Offset LLZ.

Some strands of the power line were taken down temporarily, with mixed results. One report showed a marked improvement, but removal of an additional strand in the same area was reported to make the structure worse, indicating possible random measurement results.

Initial assessment of the recordings shows that while the power line effects are visible as high-frequency scalloping in some segments of the approach, such as between 4 and 6 miles in Figure 5, the out-of-tolerance conditions do not

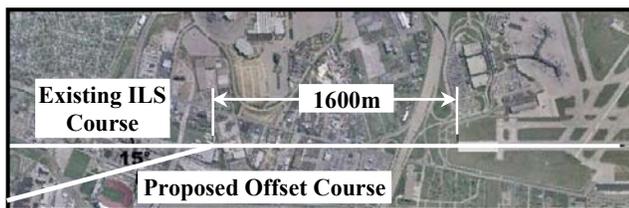
A new offset approach is being considered at a large airport, to reduce night-time noise effects over sensitive neighborhoods. The approach includes a 4-mile segment (offset LLZ with glide slope) prior to a turn to a straight-in visual segment about 1600m prior to the runway, as shown in Figure 9. The Decision Altitude would be relatively high for an ILS-type approach, perhaps 400’.

Figure 9. Overview, Noise Reduction Approach.

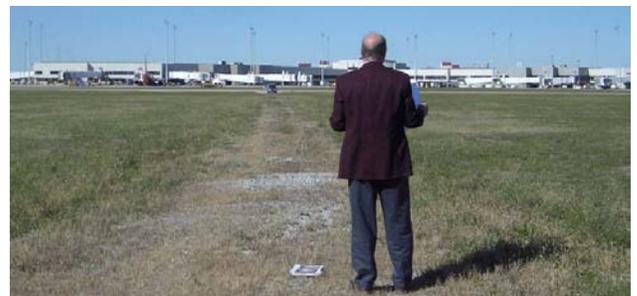
While this site provides a normal ground-mounted Localizer environment for the antenna array, the installation would be highly unusual in that the terminal is directly between the Localizer and the user aircraft on the offset approach, with the obvious expectation of taxiing and parking aircraft routinely penetrating its critical area. Figure 11 is a photograph from the approximate site location, looking in the direction of the approach.

Figure 11. View of Terminal from Localizer.

The estimated vertical angle to the top of the terminal/concourse structure is 0.7 degrees, while the approximate vertical angle to the user aircraft at the offset approach turn point (lowest use of the proposed localizer) is 2.5 degrees. Therefore the line of sight to the user aircraft is unobstructed, but the effect of the terminal structure on the signals must be determined by sufficiently advanced mathematical simulations and/or site testing [6].

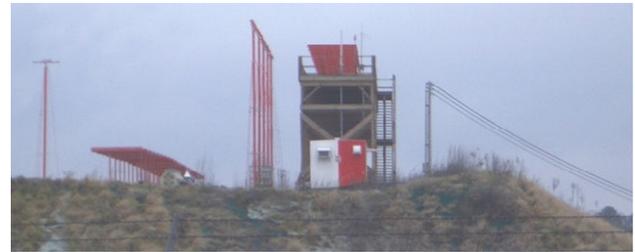
Figure 16. Platform-Mounted CAT III Localizer.

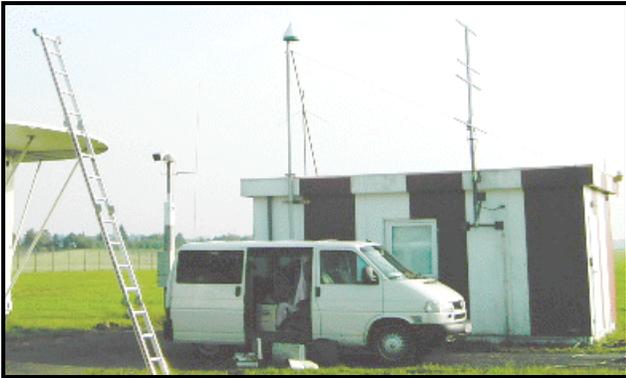
Figure 17 is a photo and Figure 18 a diagram of the very challenging flight test conditions, with an ILS marker antenna, shelter, GPS antenna, communications antenna, and a security camera, all within approximately 8-15 meters of the VOR (counterpoise: local height 3.2m, diameter 7.3m) just visible left. In addition, an airport security fence (height 2.5m) rings the test site on three sides, open to the east, at distances of approximately 20 to 80 meters. Due to the proximity of these objects, they have a large azimuthal extent and cannot be considered during simulations as point-like.

Figure 17. Site Test of Near-Field Objects.
