More Traps and Pitfalls

Stefan Jagieniak, *Aerodata AG, Germany*

ABSTRACT

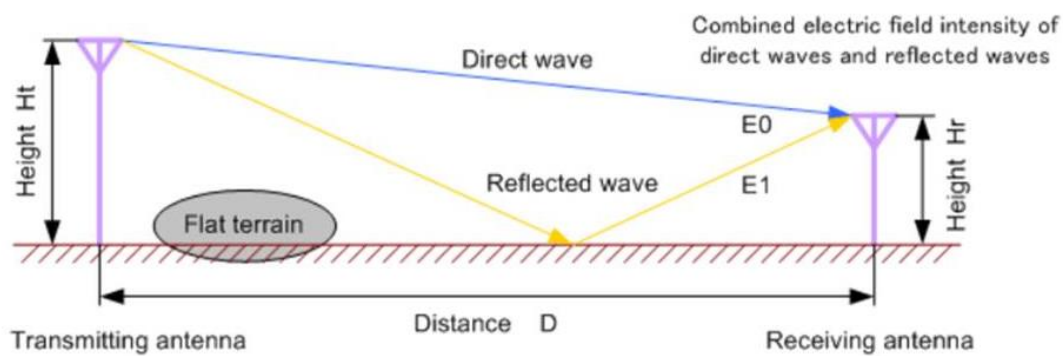
Figure 8: Principle of multipath pattern

The recommendation was to either relocate the VOR or install antenna modifications to reduce the multipath.
