Investigation of DME Multipath Propagation

Mitsuhiko Maruhashi

Flight Inspector
Japan Civil Aviation Bureau
Tokoname-City, Aichi, Japan
Fax: +81 569 381350
E-mail: maruhashi-m46ce@mlit.go.jp

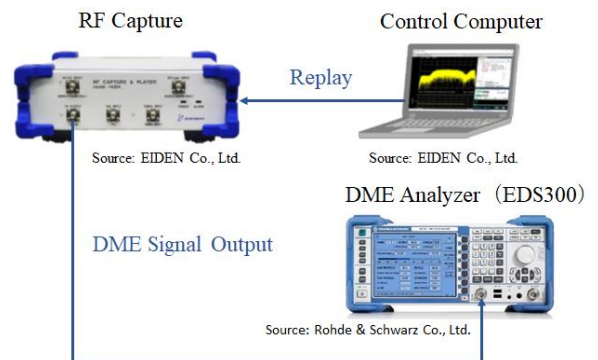
Figure 9. RF Signal Reproduction Flow

Figure 9 shows the flow of RF data's reproduction. By selecting the RF recording data on the control PC and pressing the play button, the RF capture outputs the RF signal. This signal can be analyzed by the DME pulse Analyzer.
