Study on Glide Slope's Clearance Flight Check Criteria

Shuming Liu, *Flight Inspection Center of CAAC*

ABSTRACT

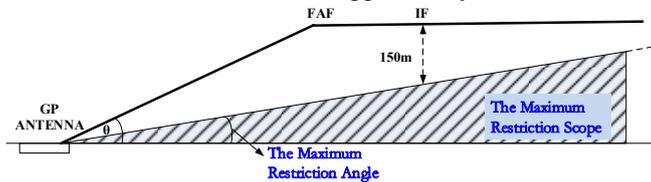
Figure 2 The Restriction Scope of The GP Angle

If the GP clearance check cannot start from 0.45θ due to terrain, then signal below GP path angle should be restricted, and the restriction conclusion should meet the following requirements:

1. The deviation of the restricted angle must be more than $-190\mu A$.
2. Taking account of the $150m$ minimum obstacle clearance (MOC) of the intermediate segment, if there is no step descend procedure between IF and FAF, the restricted angle should not be higher than the angle of the point which is $150m$ below IF, as shown in Figure 2.
3. If there is step descend procedure between IF and FAF, the restricted angle should not be higher than the angle of the point which is $150m$ below the start point of the level-flight segment before intercepting the GP, as shown in Figure 3.
4. If such restrictions are applied for the first time, it shall be approved by the administrative agency.

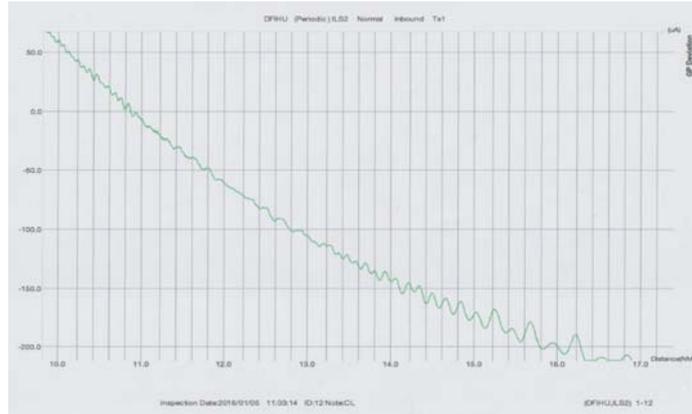
Figure 4 An unacceptable GP clearance curve

As shown in Figure 4, the GP DDM does not increase **smoothly** from $-190\mu A$ to $0\mu A$, there is obvious roughness/scalloping and the GP clearance result is unacceptable according to the flight inspection principles followed by CFIC.

According to the above analysis, we suggest that the tolerance of the roughness/scalloping is set according to the DDM where the roughness/scalloping happens. However, the curve shown in Figure 4 has several roughness/scalloping and it is not the optimal working condition of the equipment, so it should be optimized and adjusted.

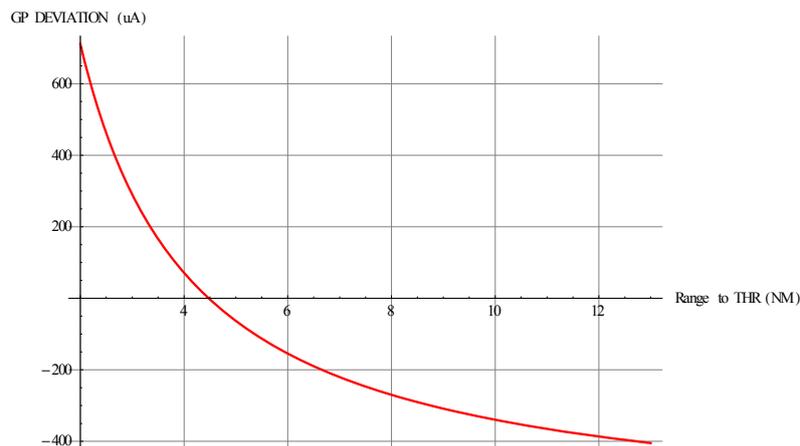
Figure 5 A GP clearance curve derived from theoretical calculation

$$I_{dev} = (\theta - 3) \times 75 / 0.36 = \left[\arctan\left(\frac{H}{L+300}\right) \times \frac{180}{\pi} - 3 \right] \times 75 / 0.36$$

Suppose the flight height H is $450m$ high, we can draw a curve of the relationship between I_{dev} and L using Mathematic, as shown in Figure 5.

If we choose 10% deviation from linearity to determine the tolerance of the GP clearance curve, we have to draw a curve as shown in Figure 5 through theoretical calculation for each GP, and then compare the results with the check results, which is very difficult to implement. Therefore, it is appropriate to use the 5% deviation current error as the calculation factor, which means that the receiver allows a maximum 5% deviation error between the standard input and the output DDM.

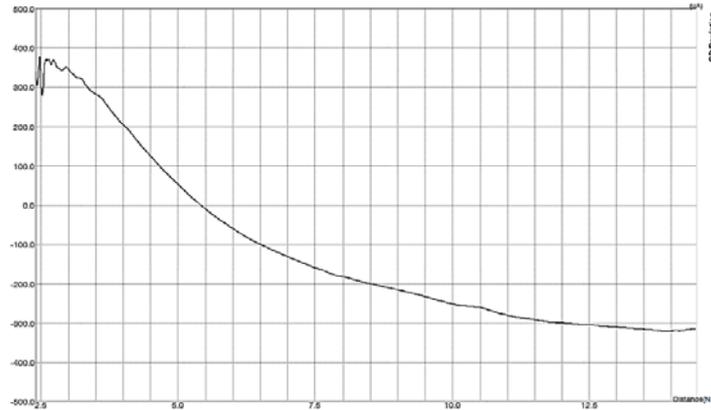
Figure 6 A Representative Acceptable Curve

Figure 6 shows a representative acceptable GP clearance curve from a real check.

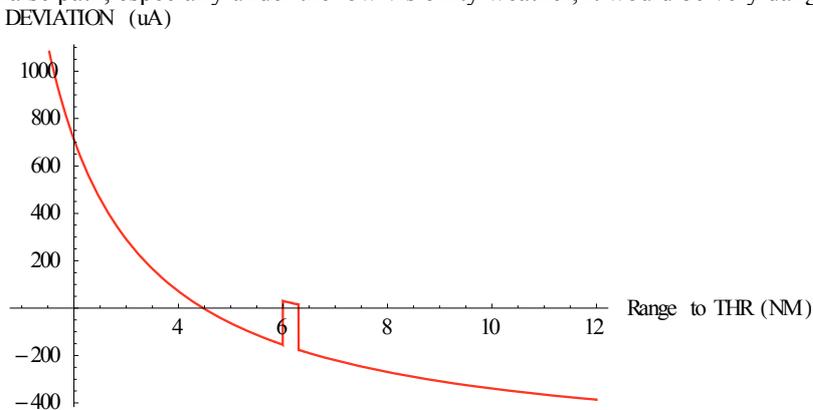
Figure 7 An Obvious False Glide Path

Figure 7 shows a GP who has an obvious false glide path at 6NM from the threshold. During the approach, if the aircraft intercepts and captures the false path, especially under the low visibility weather, it would be very dangerous.

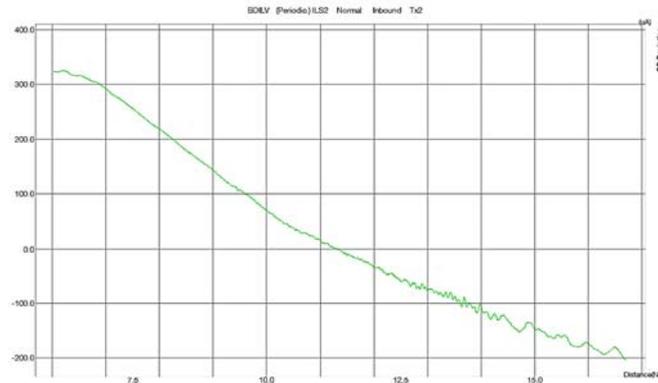
Figure 8 A Commissioning GP Clearance Curve

The GP DDM curve shown in Figure 8 was given an unqualified conclusion by inspector recently in a commissioning airport, there are 4 reasons:

1. There is roughness/scalloping between $-190\mu A$ and $-50\mu A$, the maximum value is almost $20\mu A$, far from the definition in Annex 10.
2. $-190\mu A$ appeared more than once.
3. The airport's altitude is more than $3,800m$. The weather is complex and changeable, so the GP should operate at a high level to support the flight procedures, so as to ensure the security of the airport operation in the future.
4. It is a commissioning flight inspection for the GP, and the specification shall be strictly implemented.

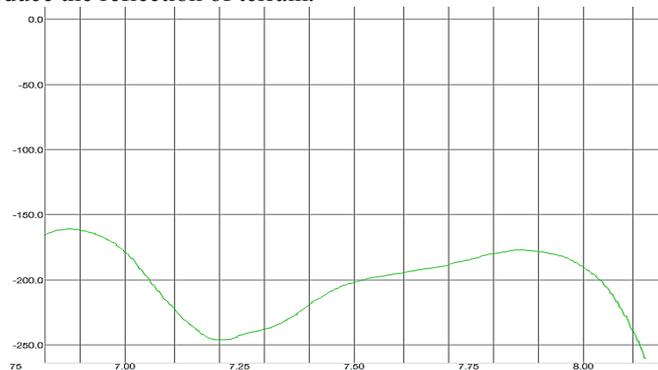
Figure 9 GP Clearance Curve before the DDM is lowered

1. Lower the DDM of the clearance transmitter, so as to lower the roughness/scalloping happens at low angle near $-190\mu A$, after that the DDM increases smoothly from $0\mu A$ to $-190\mu A$, but the path angle remains unchanged. This method can be adopted when there is roughness/scalloping near $-190\mu A$ but the curve is smooth above the angle where $-190\mu A$ appears. As shown in Figure 9 and Figure 10, after the GP DDM is lowered, $-190\mu A$ appeared only once and from $-190\mu A$ to $0\mu A$, the DDM curve is smooth.

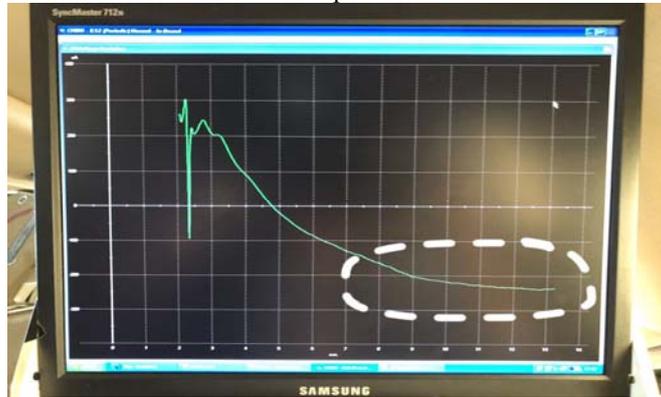
Figure 11 A GP Clearance Curve whose DDM is only $-240\mu A$ at low angle

For some GP, even if the GP clearance curve meets the specification requirements, the equipment may also have other problems. As shown in Figure 11, the inspector found that the clearance curve is smooth in terms of the results, but the DDM of low angle is too close to $-190\mu A$, which is only $-240\mu A$, and it is different from common facilities. Then experts checked the ground site, it was found that the antenna base loosened due to perennial rain and the antenna tower leaned forward.
